# WAGGA WAGGA THEATRE SCHOOL OF ARTS

## Report on NCC Vol 1 BCA Compliance

**Eric Martin and Associates**

**23 October 2015**

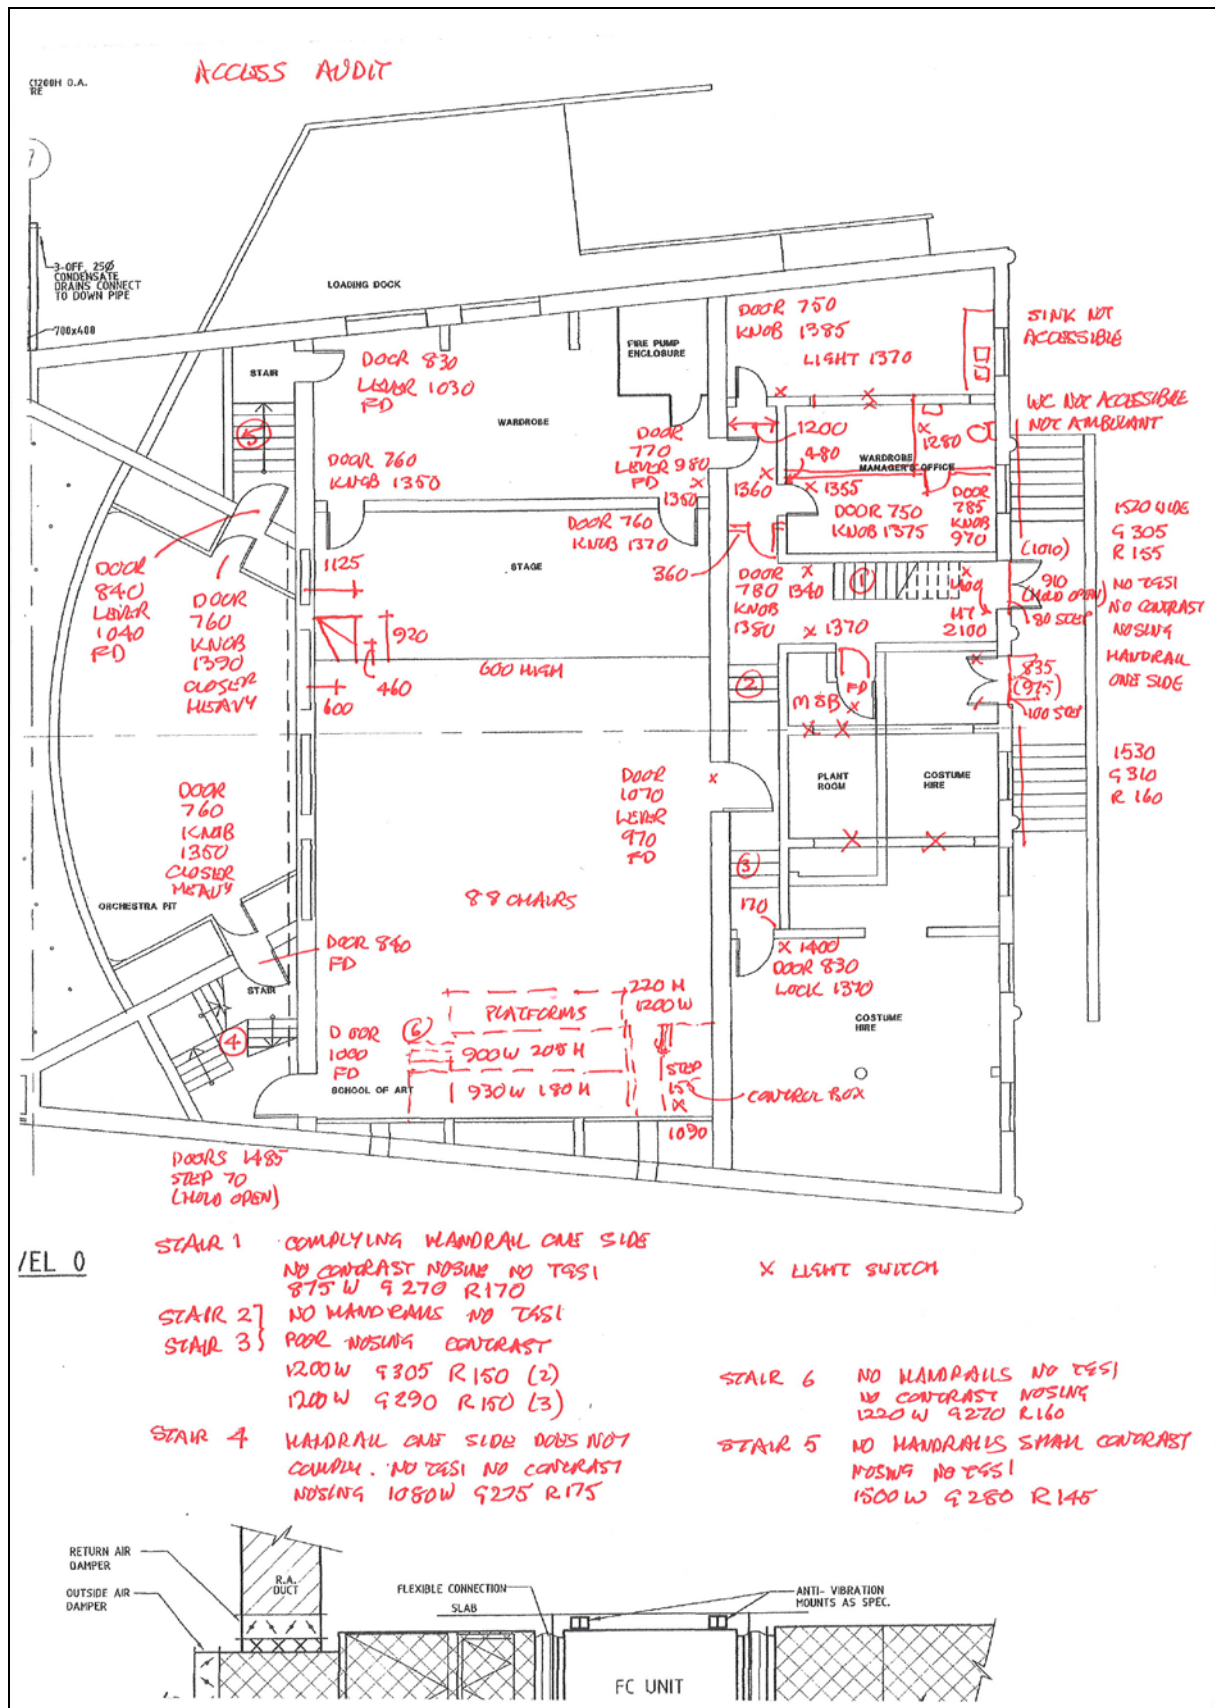
Figure 1: Marked up plan showing access issues

The main public access is from the side where the double doors are held open providing a clear opening of 1485mm but including a step of 70mm.

The administration entry is at the rear from stairs that do not comply with only one handrail (although stairs in both directions compensate for this), no contrast nosing and TGSi. The double doors can be held open providing a clear opening of 910mm but with a 80mm step. The low height (below 2000mm) at the admin entry does not include TGSi or a suitable barrier.

There is no lift to the theatre level from the public access. The stairs do not comply with a handrail one side, incorrect handrail, no contrast nosing and no TGSi.

There are internal stairs to restrict access from the back of theatre areas to the theatre. These stairs do not comply with no hand rails, no TGSi and poor contrast nosing.

All doors do not comply with most being too narrow, having inadequate circulation and many have knob handles and hardware that is too high.

There is one toilet which is neither accessible nor an ambulant facility and signage is non-compliant.

All light switches and security switch are too high.

- Rectify breaches of fire rating walls.
- Add handrails each side to AS1428.1 and contrast nosing to all stairs but maintain 1000mm clear width in main entry stair.
- Widen or relocate the admin entry to provide a minimum 1000m clear passage past the stair.
- Seating to be linked.

- Remove steps at entrances.
- A lift to the theatre level.
- A lift or ramp to the rest of floor level.
- An accessible toilet and signage.
- New doors and layout to meet circulation requirements.
- Replace exit signs including tactile/braille signs.
- Add TGSi to the general use stairs.
- Provide foyer.

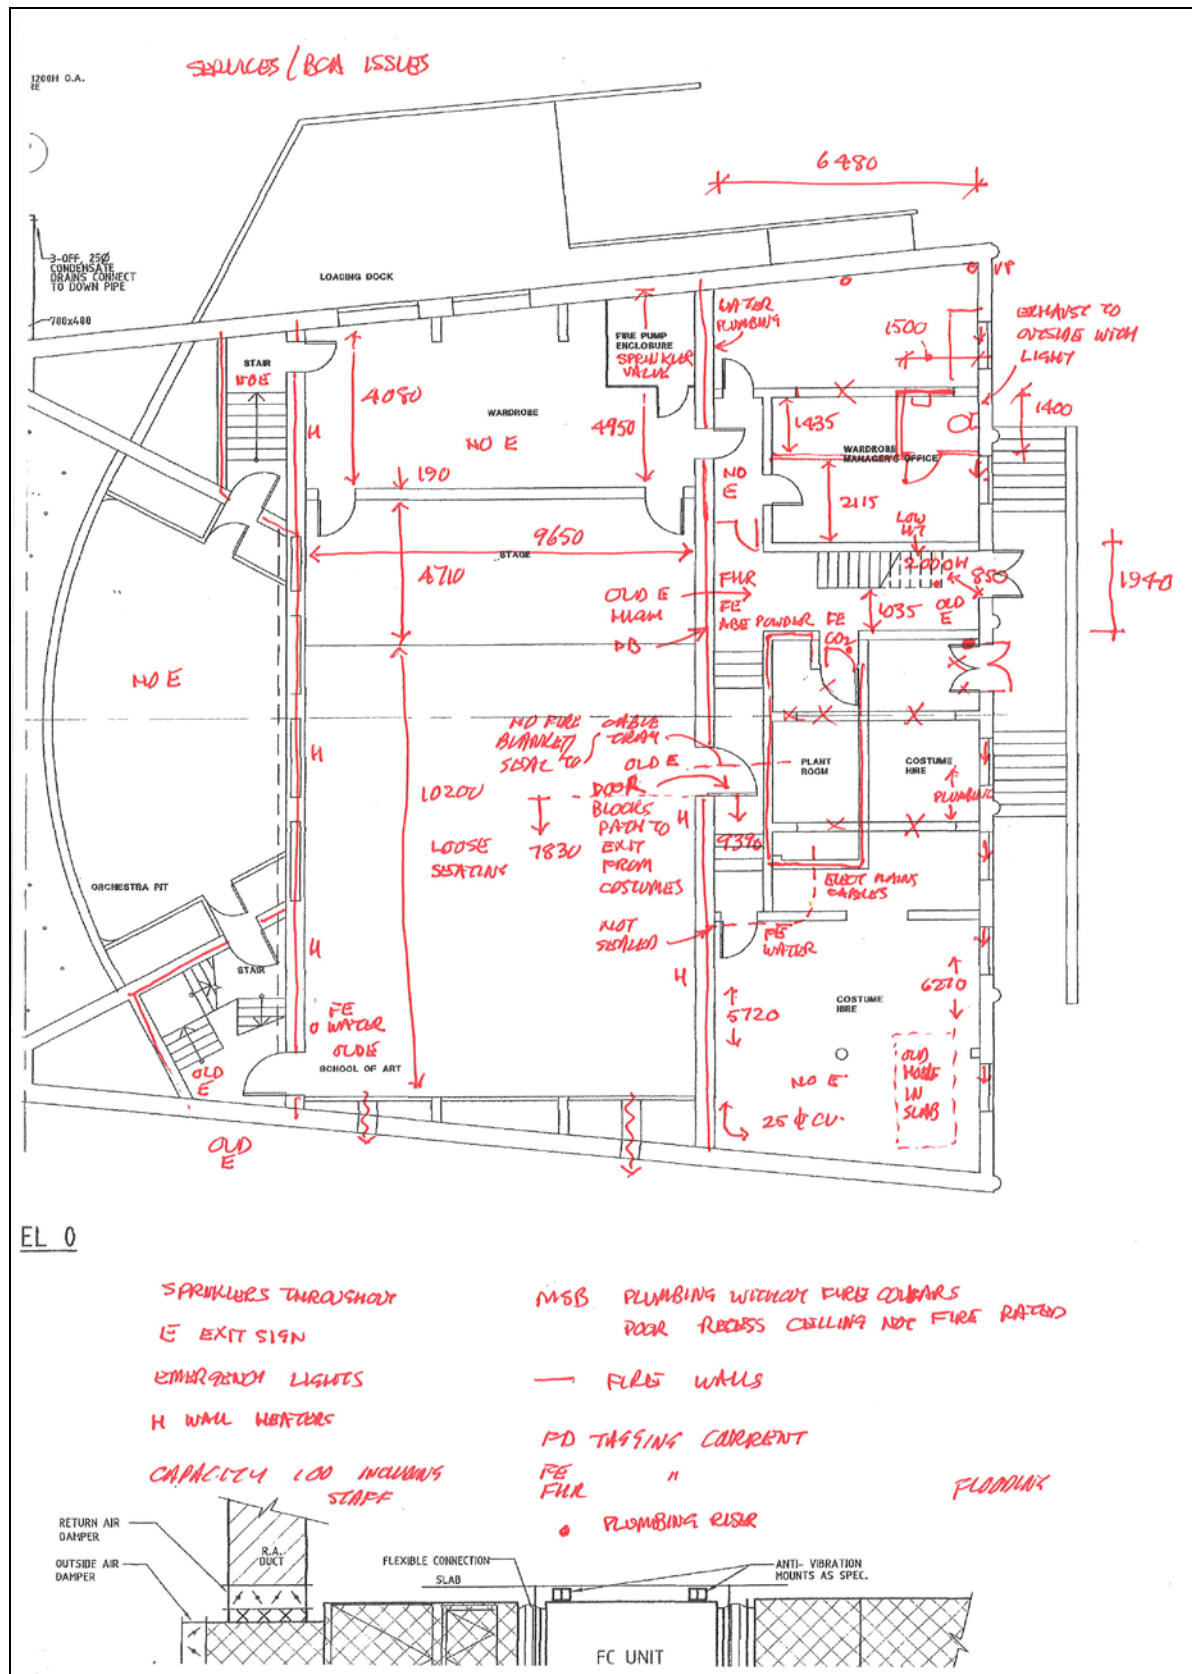
### Figure 2: Annotated Plan

Risers/goings of all stairs comply but the balustrade at the main entry has openings in excess of 125mm diameter.

These exist but are the old type (not the running man) and do not provide coverage to office corridor and back stage.

The exit path to the main public entry complies but the exit to the admin entry is not wide enough as it crosses under the stairs (850mm wide).

There are fire rated sections and the facility is fire separated from the main theatre. The other area that is fire separated is the MSB. Fire doors are provided and tagged but there are penetrations through walls by electrical cables and a pumping pipe. The ceiling of the entry door recess to the MSB is not fire rated.

The whole area is sprinklered and includes a FHR (although more than 4m from an exit door) and fire extinguishers are strategically placed. All services are tagged and current and would appear to be sufficient. The fire sprinkler valve enclosure is within the back stage area which is unusual.

The ventilation would appear inadequate.

This appears adequate except no aisle lights are provided.

There is effectively no foyer. NCC 2015 Vol 1 BCA clause NSW H101.3 requires a foyer space of 0.25m<sup>2</sup> per person or 25m<sup>2</sup>.
