19 Lloyd Road (cnr. of Plane Tree Road), Springvale.

Arboricultural Impact Assessment

July 2021
Ref. 21/408.

Proposed Child Care Centre, 19 Lloyd Road, Springvale.

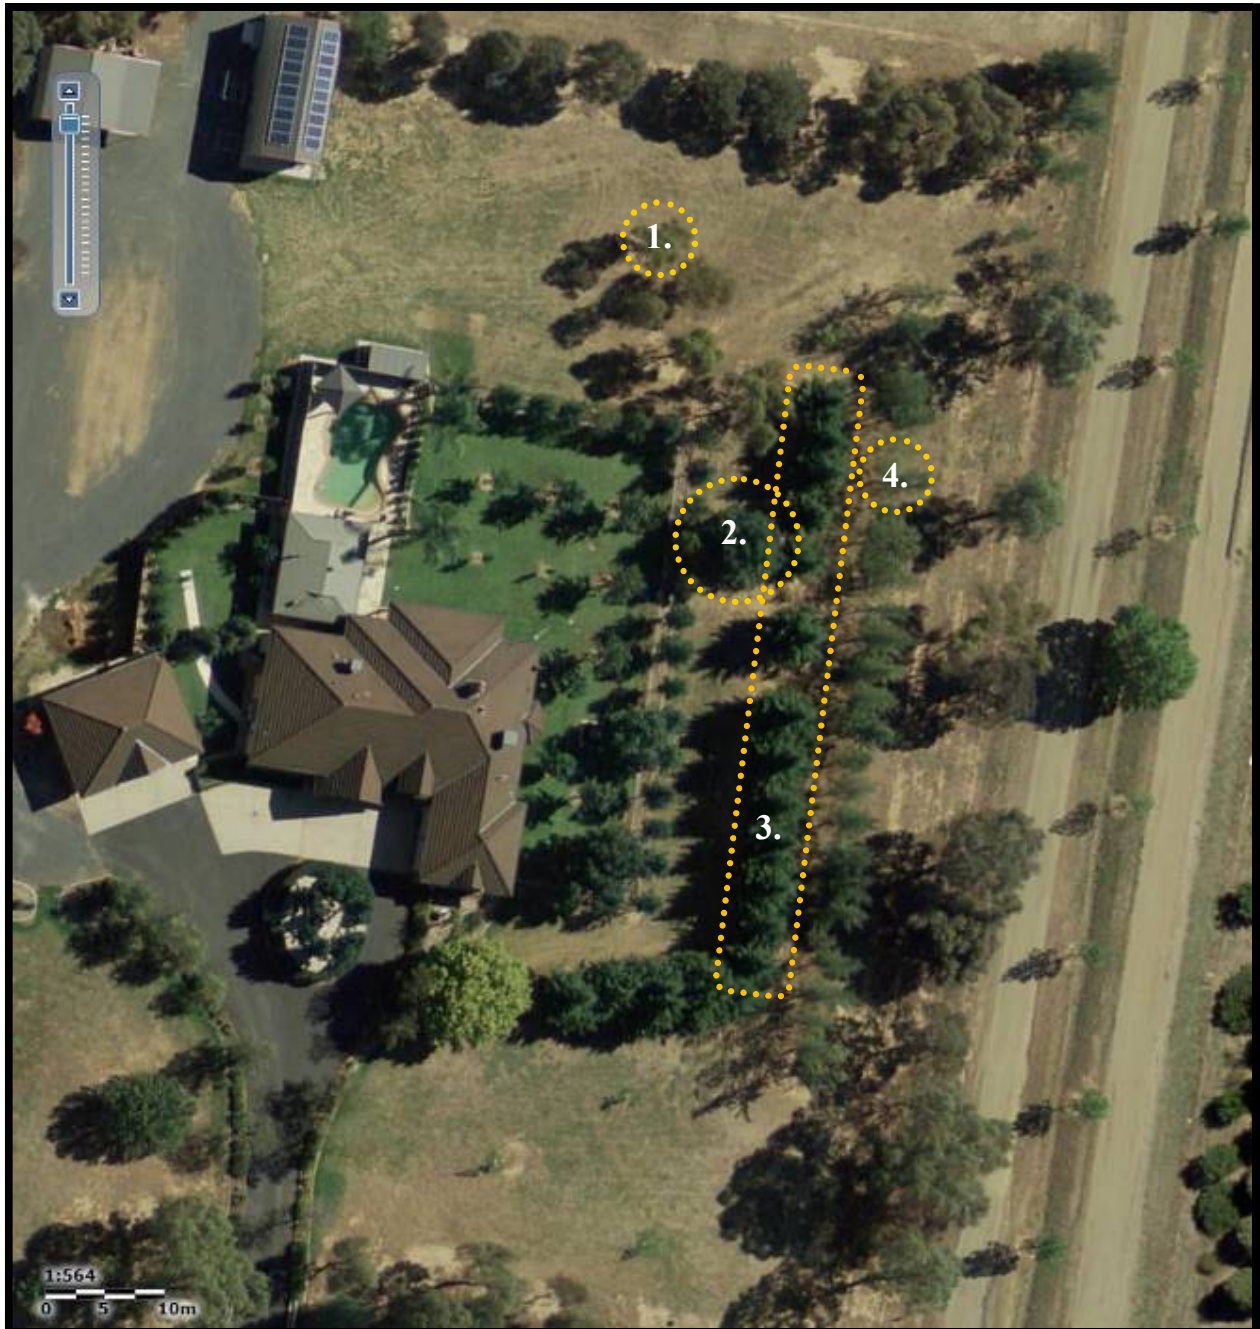
Exhibit 3 – An aerial photograph of (the eastern portion of) 19 Lloyd Road. The trees discussed in Section 4 of this report are highlighted and numbered.

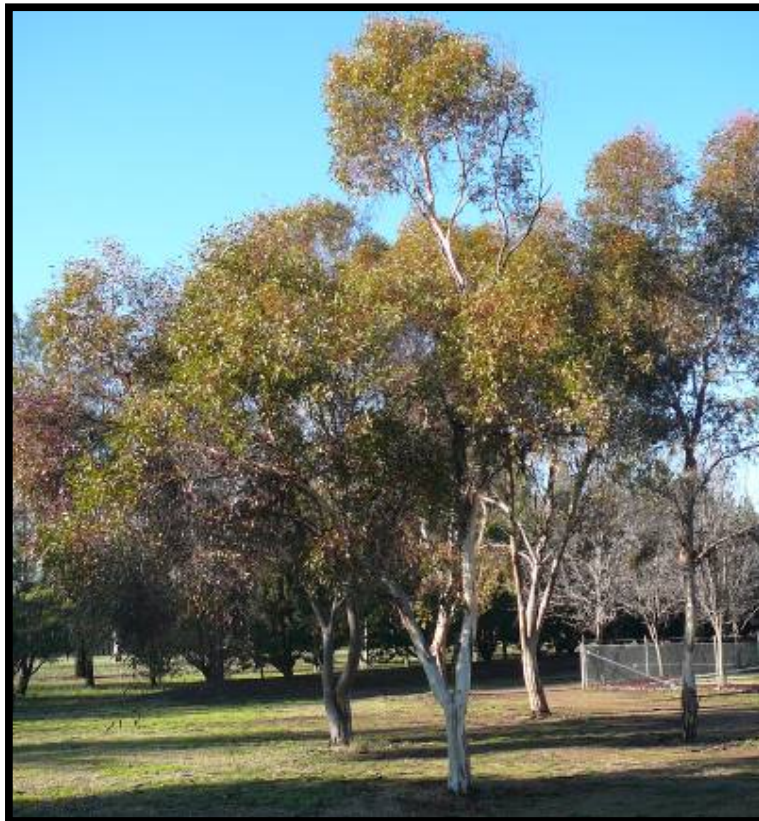
4.1 – Tree 1

Exhibit 4 –Tree 1 (in foreground) is a Red Mallee (*Eucalyptus oleosa*) in Fair condition. It is proposed that other trees within the copse illustrated will be retained.

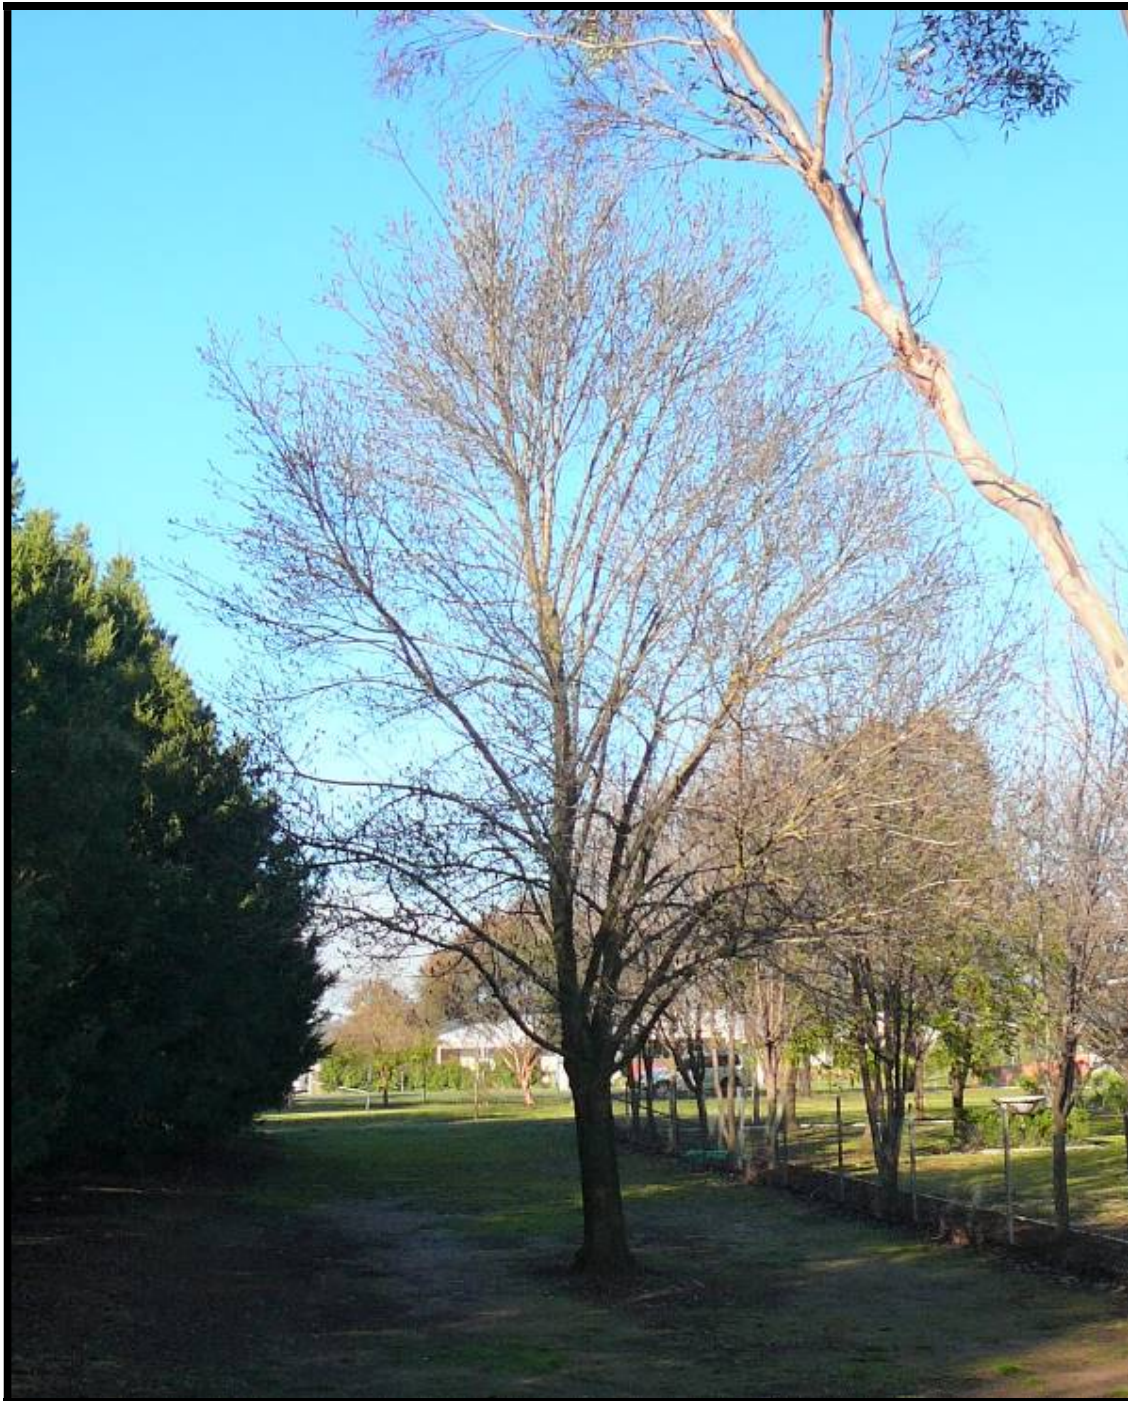
4.2 – Tree 2

Tree 2 is a young Claret Ash (*Fraxinus Raywood*) in Good condition.

Exhibit 5 – Tree 2; a Claret Ash (*Fraxinus Raywood*).

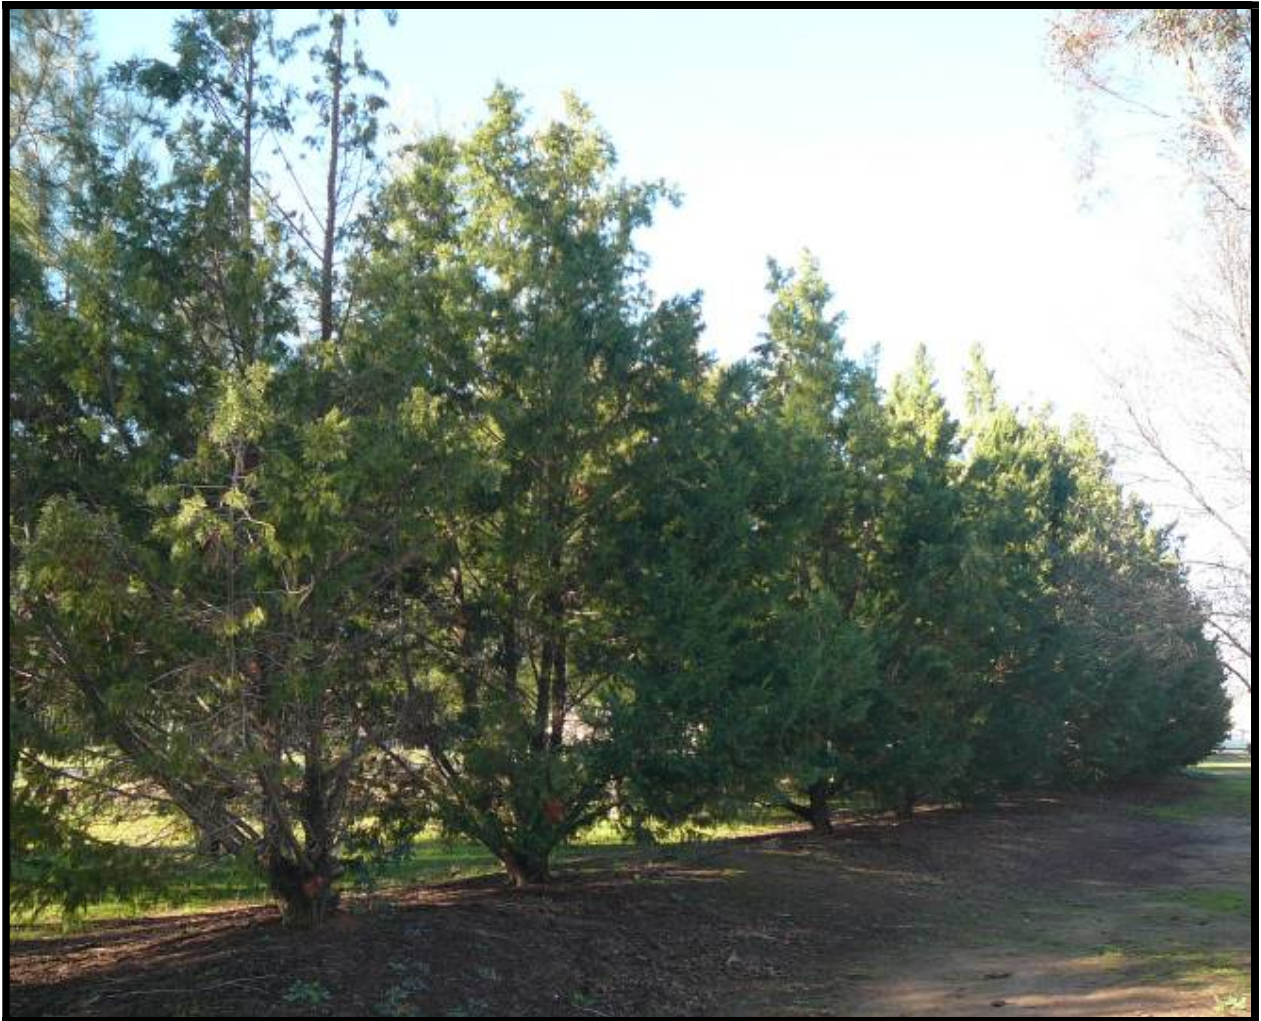
4.3 – Tree 3

Tree 3 is an avenue of Leyland Cypress (*Cupressus X leylandii*). The avenue was probably planted to form a tall hedge and provide visual privacy for the residence on the property. There are some “gaps” in the avenue, with the individual trees being of varying condition. It is proposed to remove the thirteen stems that currently make up this avenue.

Exhibit 6 – Tree 3; an “avenue” / tall hedge of Leyland Cypress (*Cupressus X leylandii*).

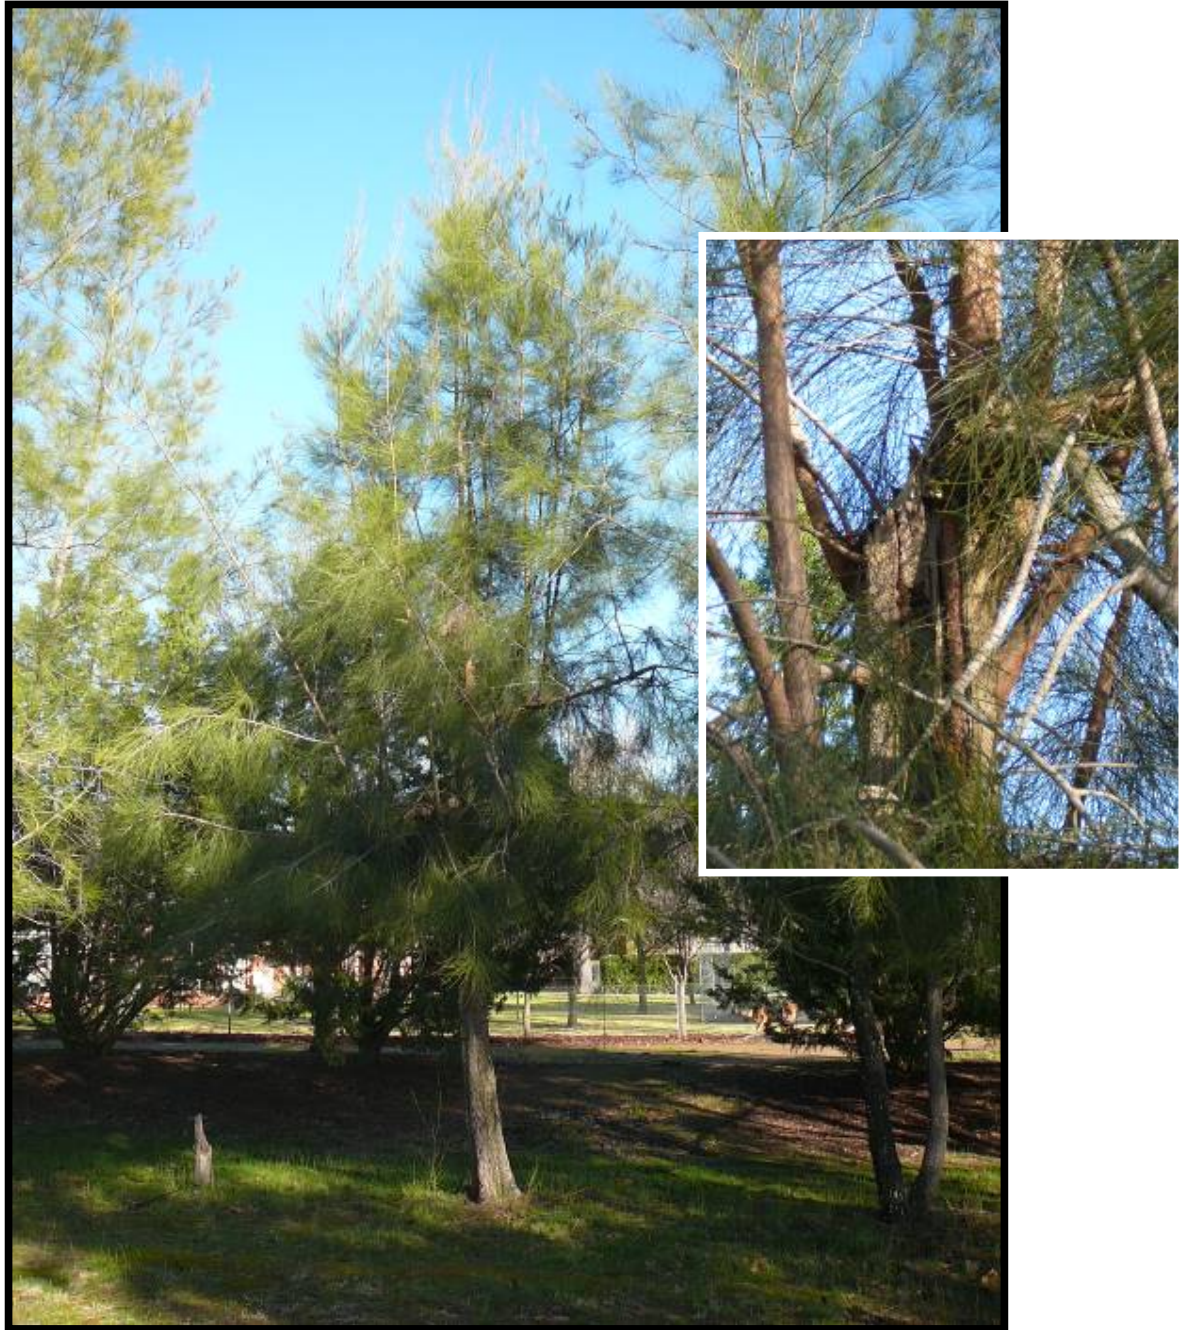
4.4 – Tree 4

Tree 4 is a River Oak (*Casuarina cunninghamiana*) that is part of a line of River Oaks to the east of the Leyland Cypresses (No. 3). Due to a structural weakness, caused by storm damage to the tree's main stem (see Exhibit 7), the tree is rated as being in Poor condition.

Exhibit 7 – Tree 4; a River Oak (*Casuarina cunninghamiana*) with a structurally compromised stem, caused by prior storm damage (**Inset**).

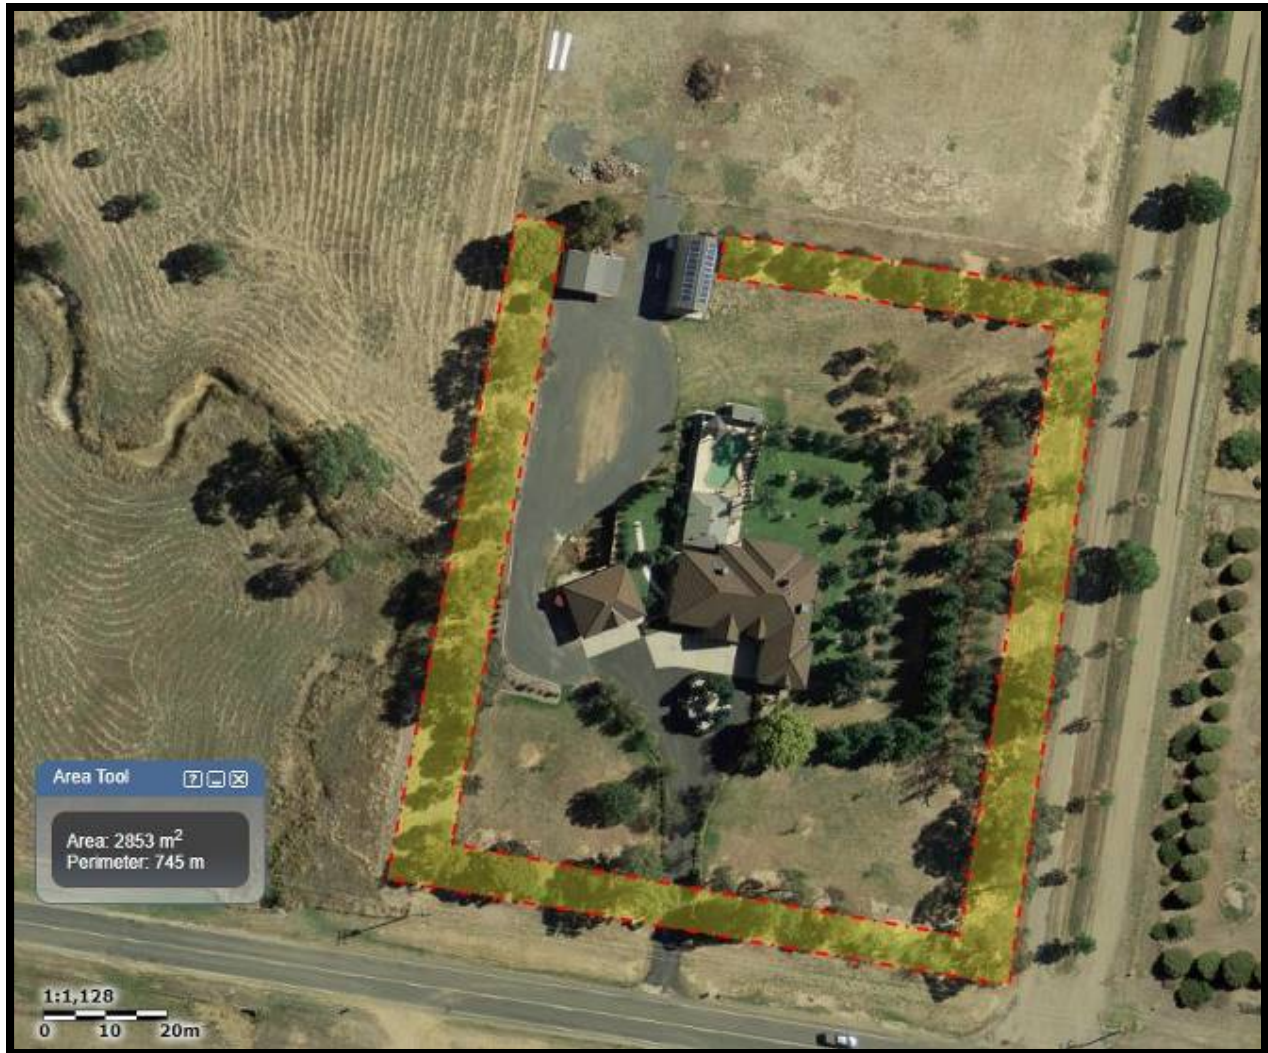
The removal of sixteen trees, fourteen of which are exotic species, does not constitute an “adverse” biodiversity impact of any of the circumstances listed in Clause 7.3. Furthermore, the perimeter of the subject property has previously been planted with native trees, none of which will be impacted by the proposed development. This perimeter native vegetation constitutes a canopy cover of approximately 2,800m² (see Exhibit 8).

As illustrated in Exhibit 8, the proposed tree removals will have negligible impact on the property’s native vegetation cover, and the requirements of Section 5.3 have already been met and will be maintained by the proposed development.

Exhibit 8 – Approximate area of canopy cover of the “perimeter planting” of native trees on the property 19 Lloyd Road.

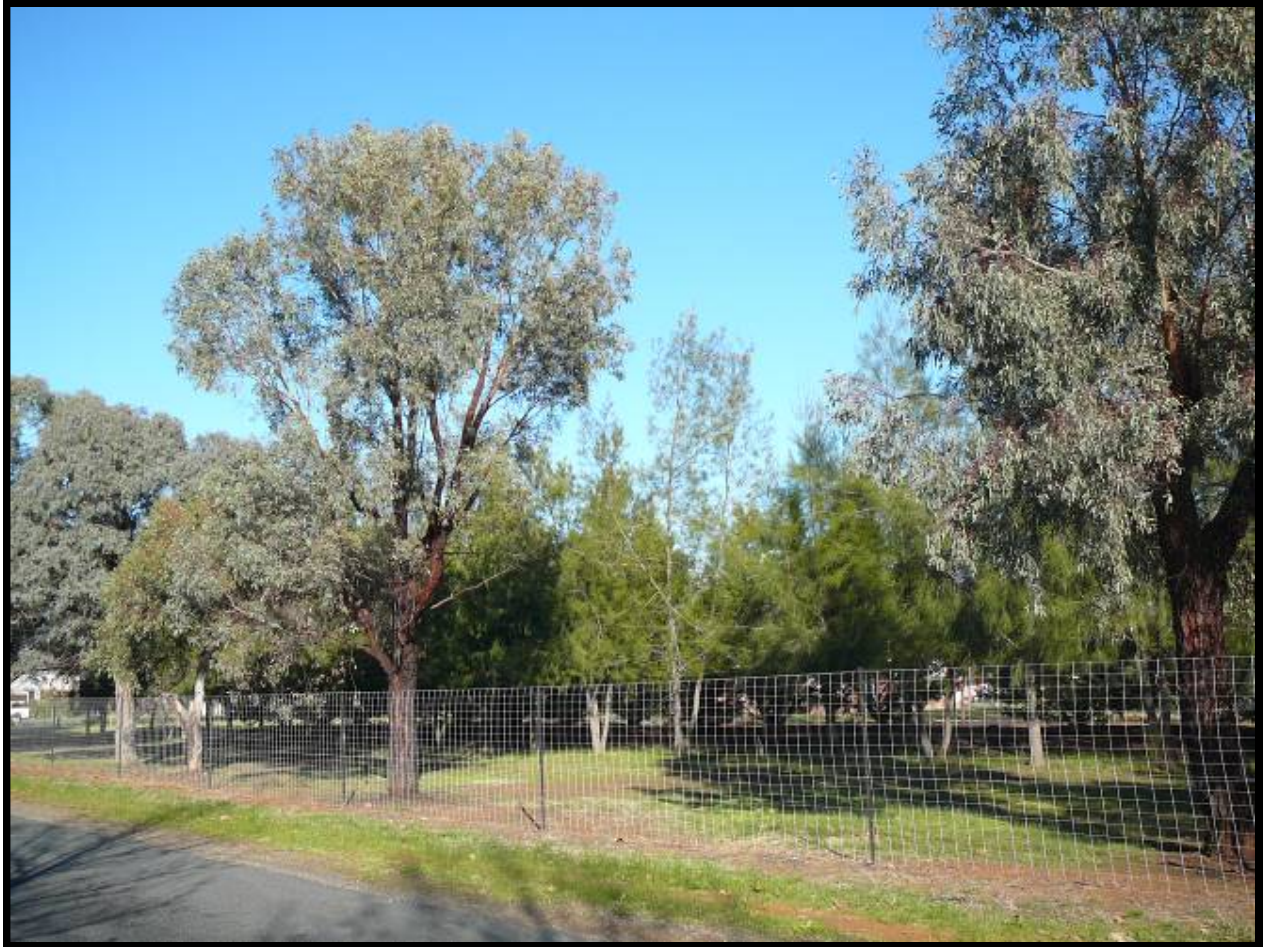
The proposed tree removals will also have negligible impact on the streetscape amenity from Plane Tree Drive (see Exhibit 9).

Exhibit 9 – A view to 19 Lloyd Road from Plane Tree Drive. The property’s perimeter tree planting (foreground) and the avenue of River Oaks (middle ground) will be retained by the development proposal. The proposed removal of the Leyland Cypress “behind” (to the west of) the River Oaks will have negligible impact on the streetscape of this road frontage of the property.
