**ARBORICULTURAL ASSESSMENT FOR  
DEVELOPMENT – 51 SIMMONS ST WAGGA WAGGA**

There is planned development for *Multi Dwelling Housing – 2 x two storey units to rear of existing dwelling, new single garage and associated tree removal works* at 51 Simmons Street Wagga Wagga. Wagga Wagga City Council development application DA20/0109 applies.

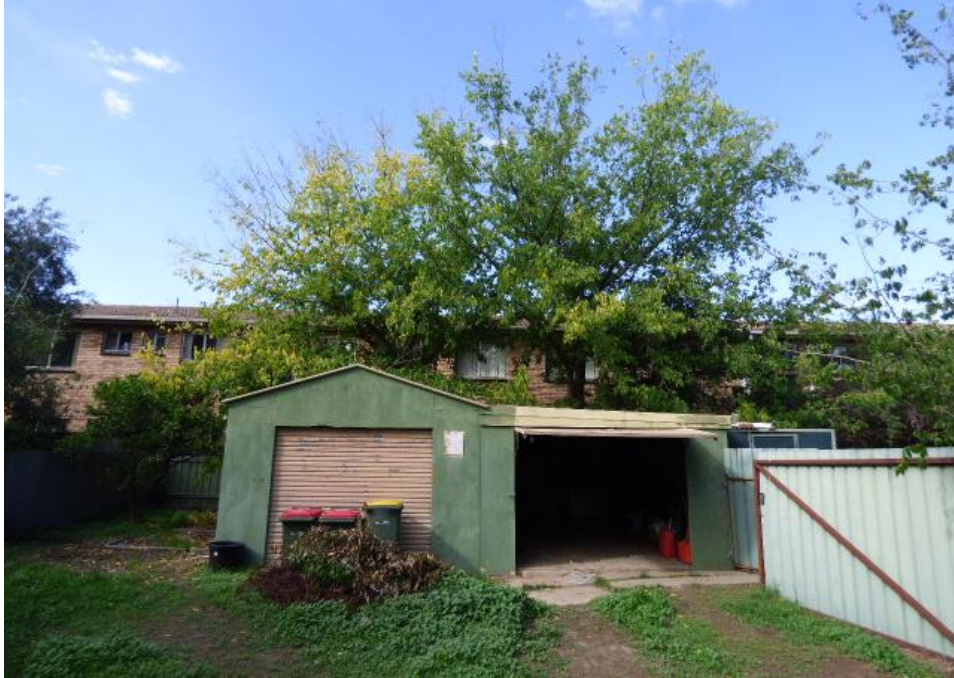
**Photo 1 – Trees 1 and 2 – Celtis Species** located between current shed and south boundary fence.

Trees 1, 2 and 4 are Celtis species that have established as a weed or nuisance tree from bird droppings. Trees 1 and 2 cannot be retained as they are in direct conflict with the proposed development. Tree 4 is already hard against the north fence and should also be removed.

1. Trees 1, 2 and 4 should be removed.
2. Tree 3 should be retained if possible.
3. Tree 5 – Tree on WWCC property requires the following measures for protection and consideration of the development.
  - a. The south side of the canopy should be pruned – reduced and uplifted by about 30-40%. The pruning needs to achieve sufficient lifting to allow light commercial vehicles access to the development site and allow at least 2 meters clearance on the boundary line of 51 Simmons Street.

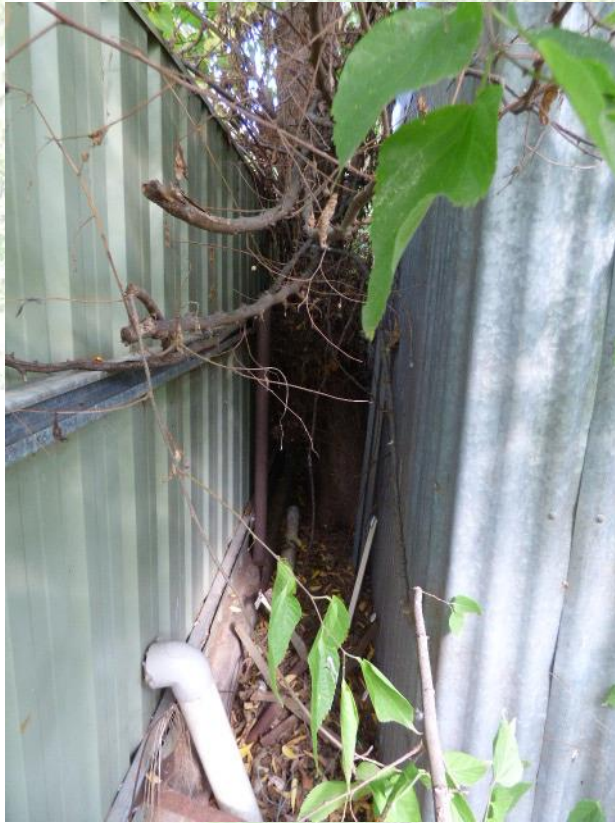
**Photo 2 – Tree 1 Celtic Species** – stem in location between shed on right and south fence on left. Tree has already outgrown the available space.

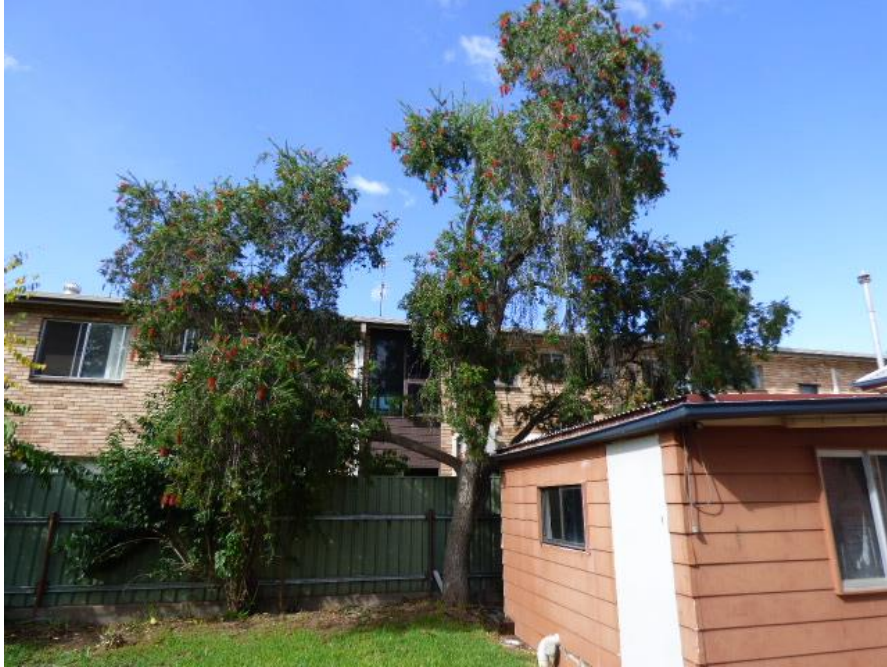
**Photo 3 – Tree 3 – Callistemon species** in location at rear of current dwelling.  
Tree should be retained if possible as an Australian native suited to the local environment and provides foraging sties for native birds.

Tree 3 – Callistemon species, is a small mature tree with positive environmental values, particularly as a foraging site for native birds. If a TPZ of 2.5 to 3m on the property of 51 Simmons can be maintained then the tree should be retained with a loss of about 10% of the TPZ. If this is not possible then the tree should be removed and the landscape design for the development should take into account its replacement.

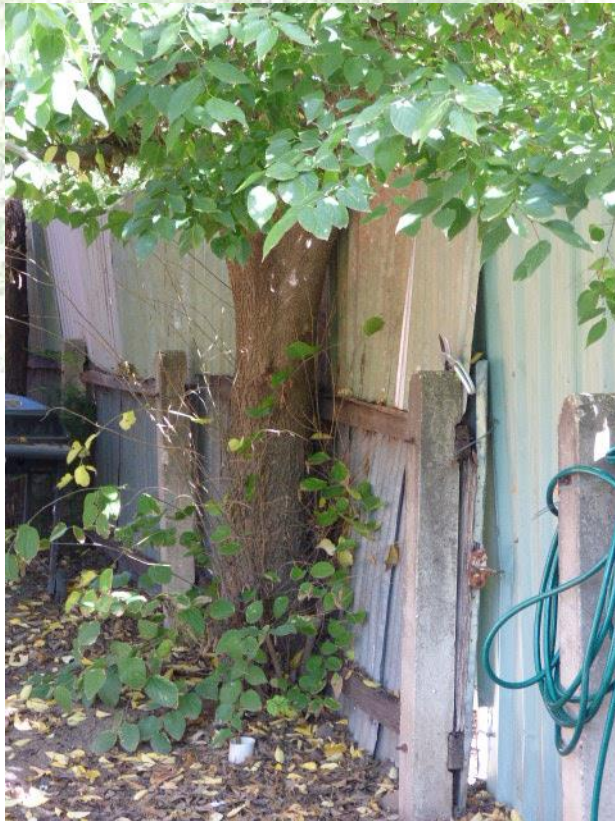
**Photo 4 – Tree 4 – Celtis species** – stem hard against north boundary fence.

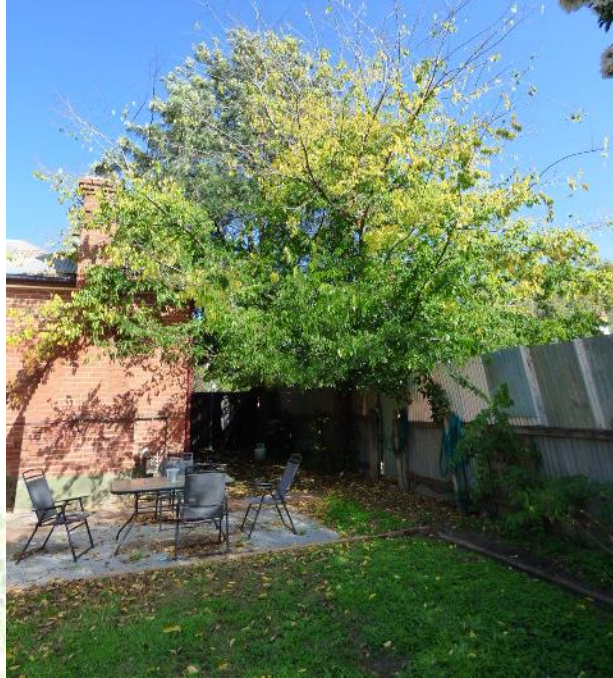
**Photo 5 – Tree 4 in location** – young semi mature tree has already outgrown its available space. Tree seed has been disposed by birds in location.

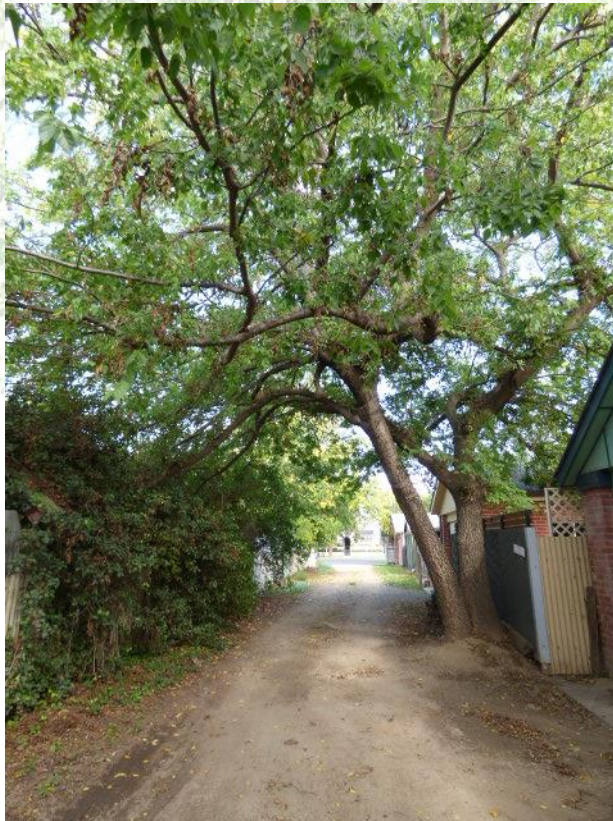
**Photo 6 – Tree 5 Celtis Species on WWCC property** – unnamed laneway or pathway between 51 Simmons and 66 Kincaid St.

Tree 5 has likely established in a similar fashion as described above, however the tree has more space and is considered close to mature dimensions. The tree is effectively owned by WWCC and with protection measures and some canopy pruning the tree can effectively be retained. Canopy pruning will also alleviate potential for the stem system to fail.

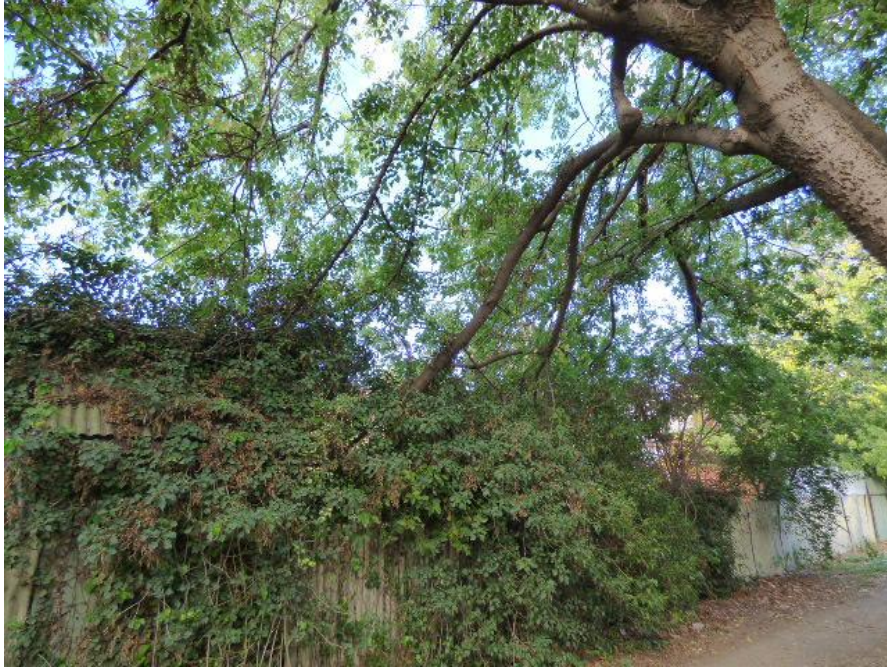
**Photo 7 – Tree 5 – WWCC tree in laneway** – canopy encroachment into 51 Simmons Street that will require management.

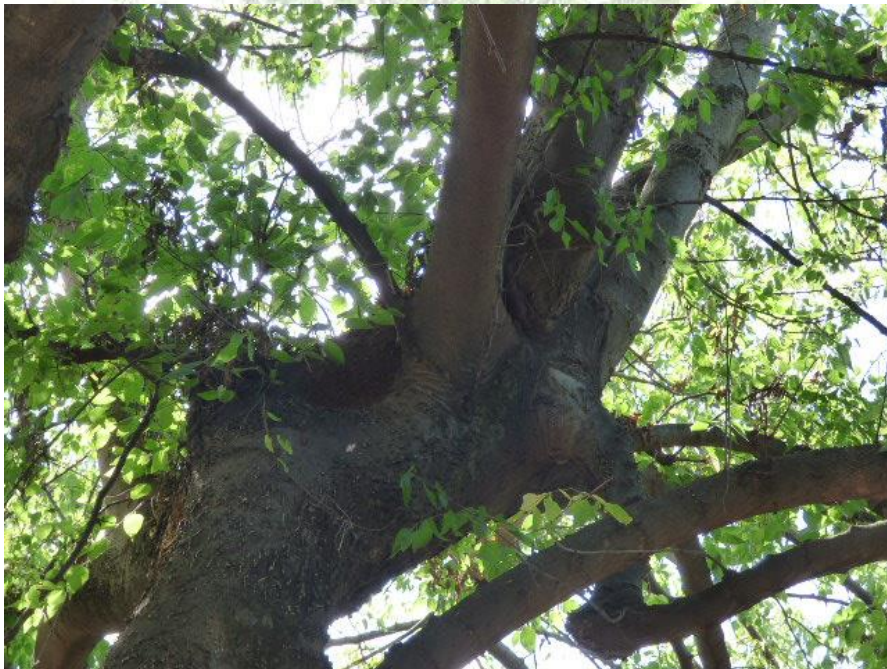
**Photo 8 – Tree 5 – south leader** of tree has been lopped as circled – epicormic shoots or stems have good attachment over laneway area.

- i. The pruning should occur prior to the development commencing.
  - b. There should be specific terms in the consent to ensure that waste, materials or other items are not stored or dumped under the tree, and that the tree is protected as part of the development consent.
  - c. The south leader of the tree should be fitted with protection barriers as per *Australian Standard 4970 – 2009 - Protection of trees on development sites – page 17* – to prevent vehicle and plant impacts to the tree stem, which is a WWCC asset – ([See Diagram 4 below](#)).
4. The landscape plan for the development needs to appropriately consider the loss of 3 or 4 young trees with appropriate replacements.
