Report on
Desktop Geotechnical Assessment

Planning Proposal - Rowan Village
7066 Holbrook Road, Rowan

Project 210894.01
April 2022

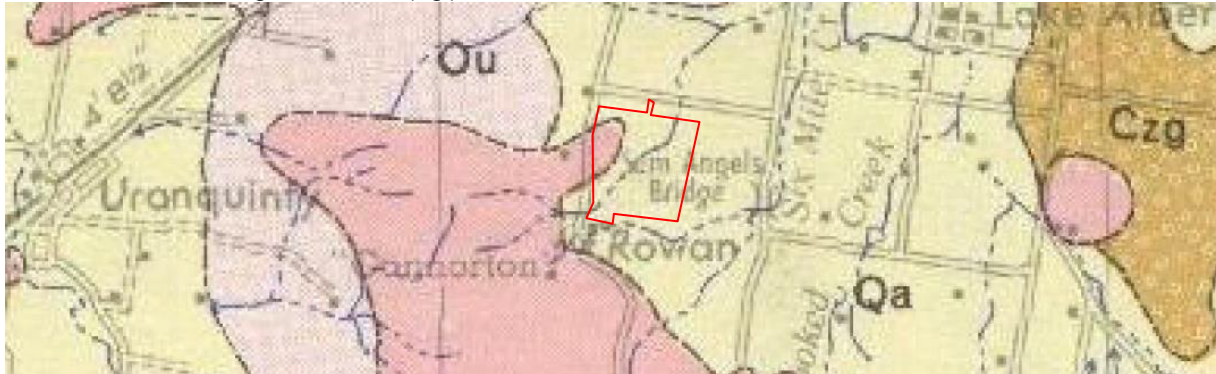
Figure 2: 1966 Wagga Wagga 1:250,000 Geology Map with approximate site location (outlined in red). Alluvium is mapped as yellow and the granite is mapped as pink.

Published mapping indicates that the site is underlain by Quaternary alluvium that comprises of gravel, sand, silt and clay. A small portion of the western part of the site is underlain by Palaeozoic granite, gneissic granite and gneiss.

According to the published mapping, it is likely that the Quaternary alluvium is underlain by granite and possibly sandstone which is located to the west of site. Driller's Logs from on-site registered groundwater bores GW403836 and GW403837 indicate granite is present at approximately between 11.5 – 12.0 m below ground level (bgl).

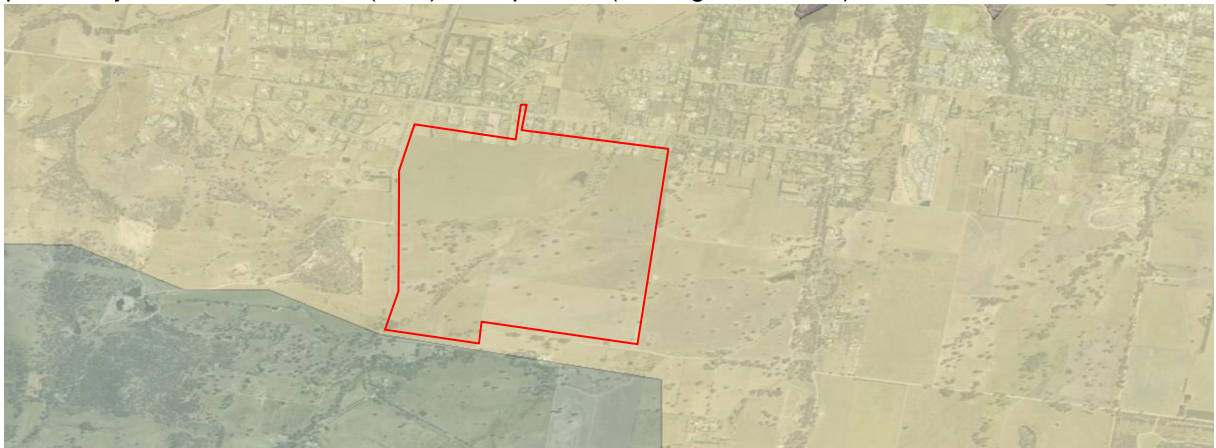
Figure 3: ASRIS – Atlas of Australian Acid Sulfate Soils map with approximate site location (outlined in red). The yellow indicates areas of low probability of ASS to be present and the green indicates areas of extremely low probability of ASS to be present.

Reference to the CSIRO's Atlas of Australian Acid Sulfate Soils online mapping portal, ([A S R I S - Atlas of Australian Acid Sulfate Soils \(csiro.au\)](https://www.csiro.au/ASRIS), accessed 16 March 2022) indicates that the site has a low probability of acid sulfate soils (ASS) to be present (see Figure 3 below).

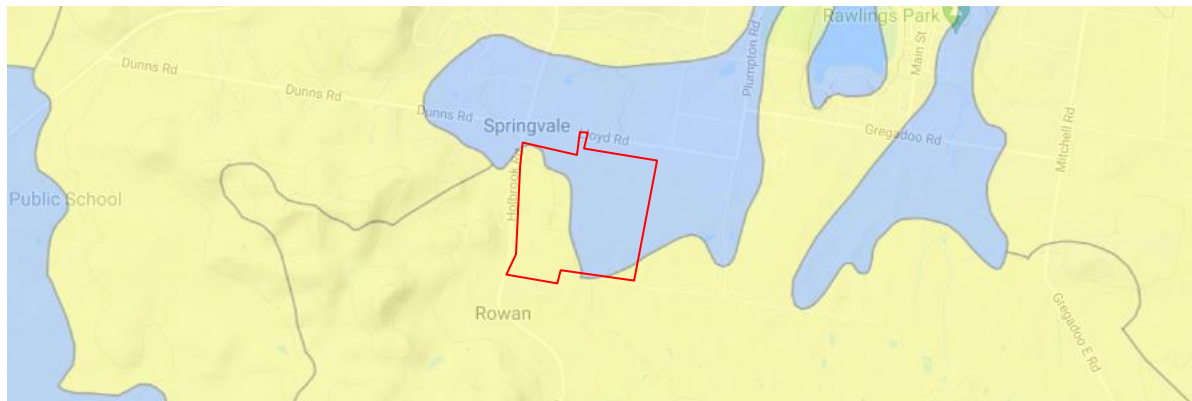
Figure 4: ASRIS – Atlas of Australian Acid Sulfate Soils map with approximate site location (outlined in red) low salinity hazard and occurrence are highlighted by the areas in blue and moderate salinity hazard and occurrence are highlighted by the areas in yellow.

Reference to NSW Department of Planning Industry and Environment eSPADE website (<https://www.environment.nsw.gov.au/eSpade2Webapp>, accessed 16 March 2022) indicated that the site has a low to moderate land salinity hazard and occurrence (see Figure 4 below).

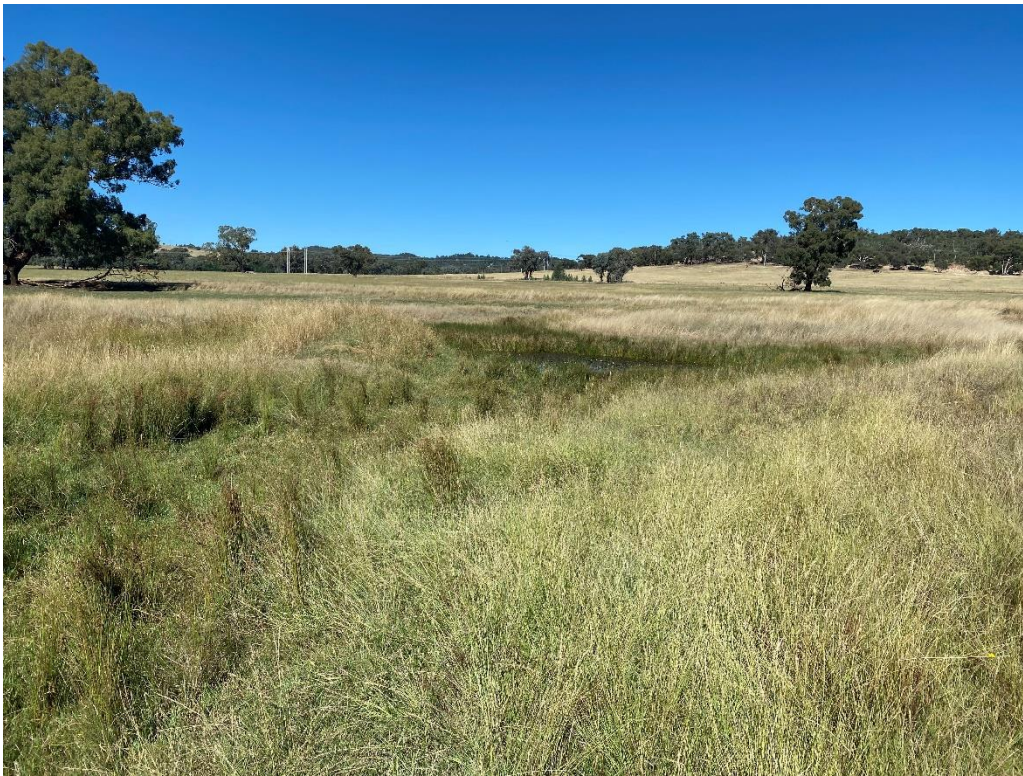
Figure 5: General view of the drainage area within the western portion of the site, looking south-west.

It should be noted that due to the dense grass and shrub coverage across the site, observations of potential fill on-site was limited during the walkover. Figures 5 – 10 show the general conditions of the site at the time of the geotechnical site walkover.

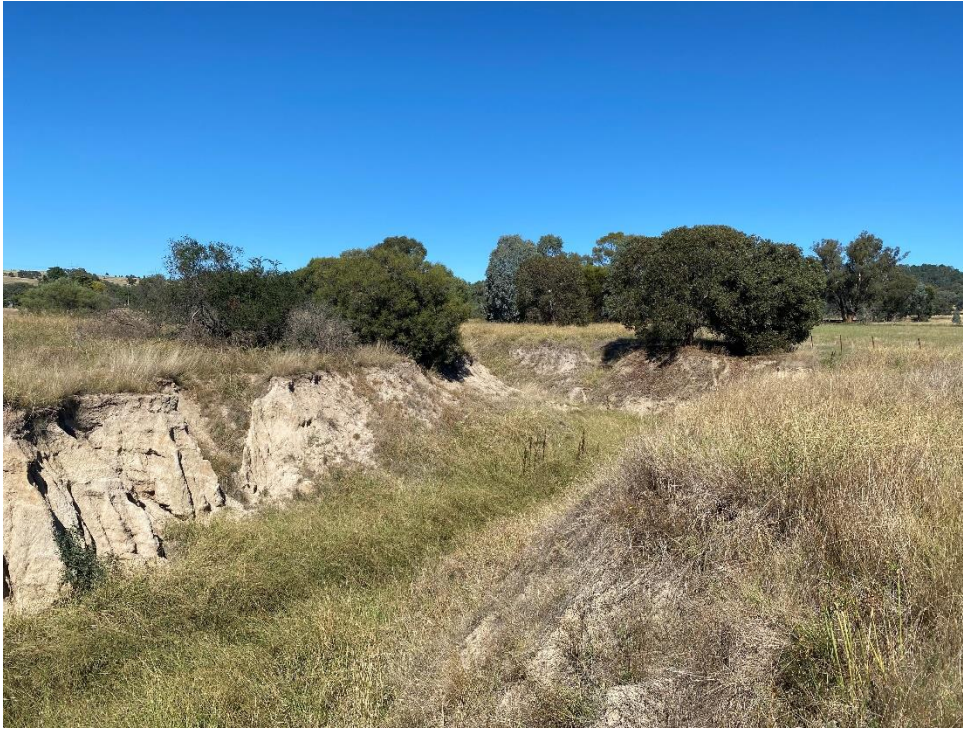
Figure 6: General view of the Stringybark Creek tributary erosion within the south-west portion of the site, looking south-west.

- The site was gently undulating and generally sloped down from the south-west to the north-east;
- Gully line erosion was present within the south-west of part of the site (within the Stringybark Creek tributary). Various materials had been tipped in a section of the Stringybark Creek tributary, including vegetation, timber, concrete, brick and cattle carcasses. The soil within the erosion line was up to approximately 3 m deep and no rock was observed within the walls of the gully. The soil comprised a mixture of silty sand and sandy clay with gravel;

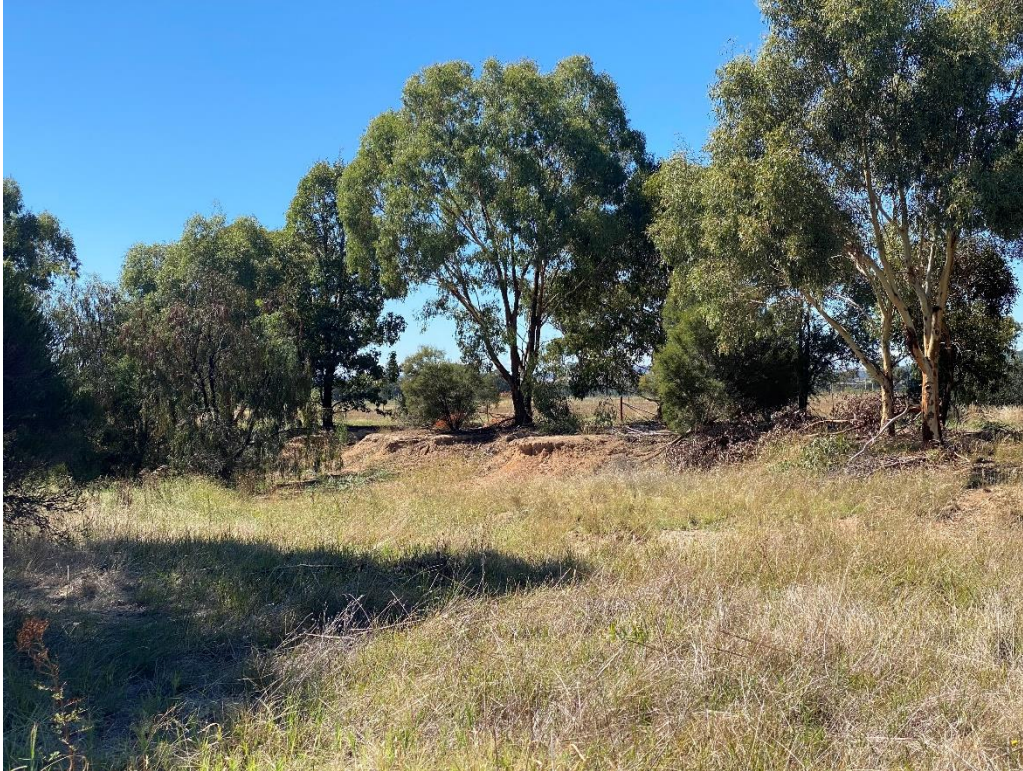
Figure 7: General view of the Stringybark Creek tributary erosion within the south-west portion of the site, looking south-east.

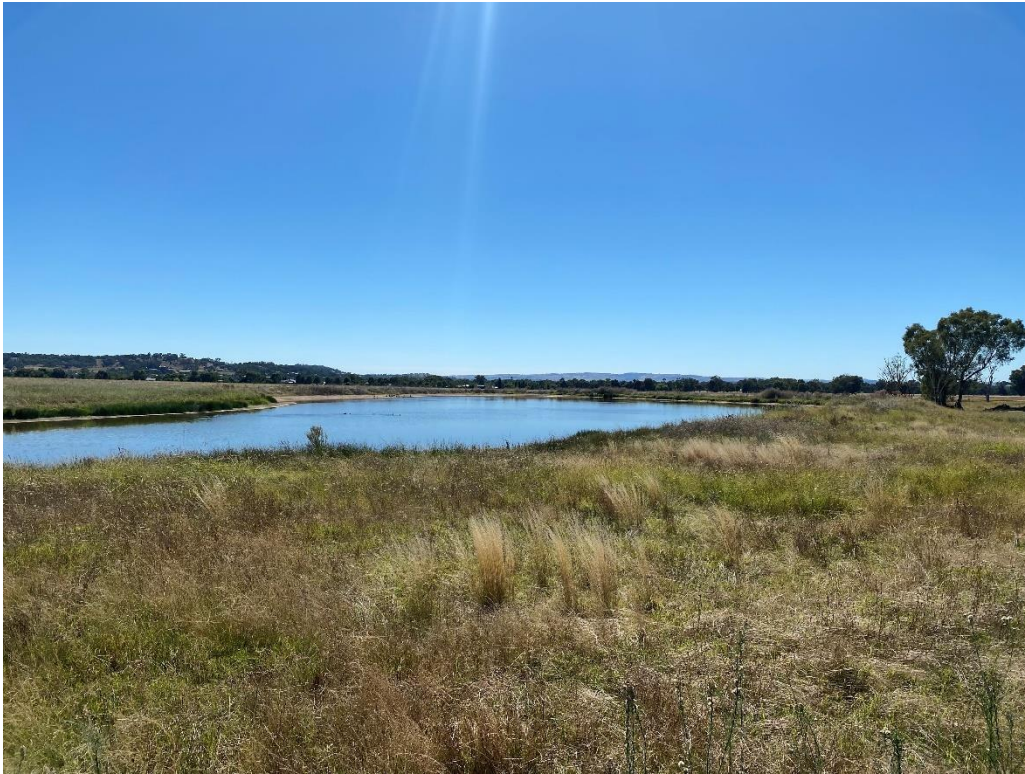
Figure 8: General view of a farm dam located within the central part of the site, on the western edge of the Stringybark Creek tributary, looking north.

- Vegetation appeared to be in a healthy condition, however some dead trees were present;
- Dam walls and embankments and contour berms were constructed with soil material and appeared to be site-won material. No refuse/building debris was observed on the surface of the dam walls;

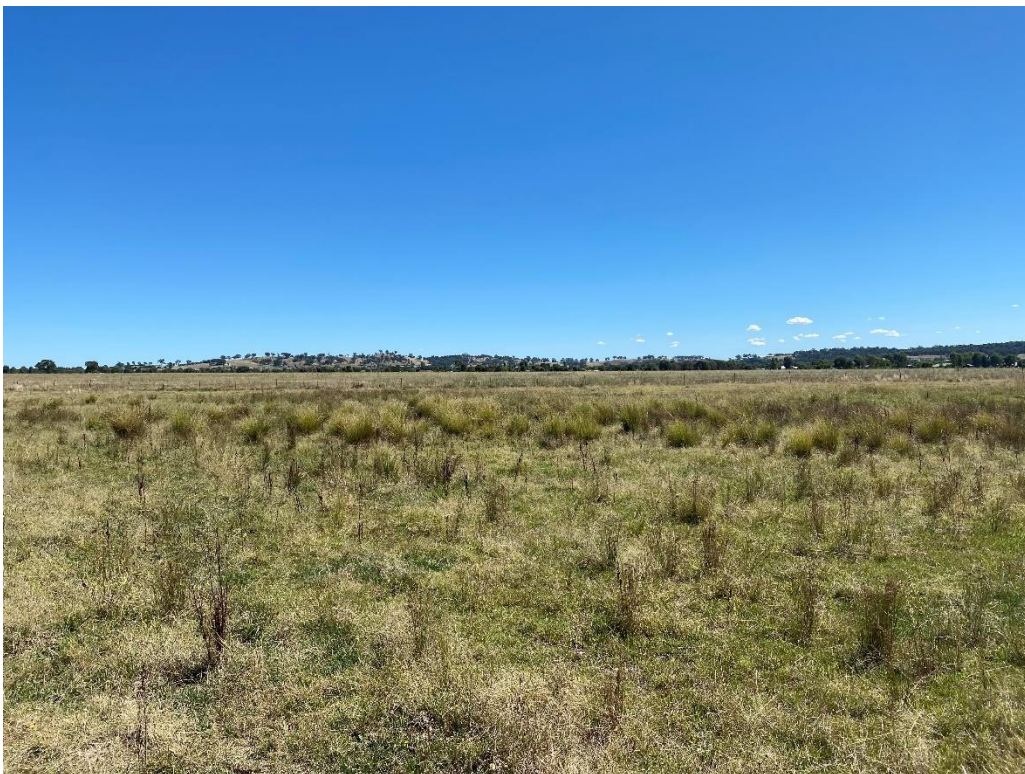
Figure 9: General view of the north-east portion of the site.

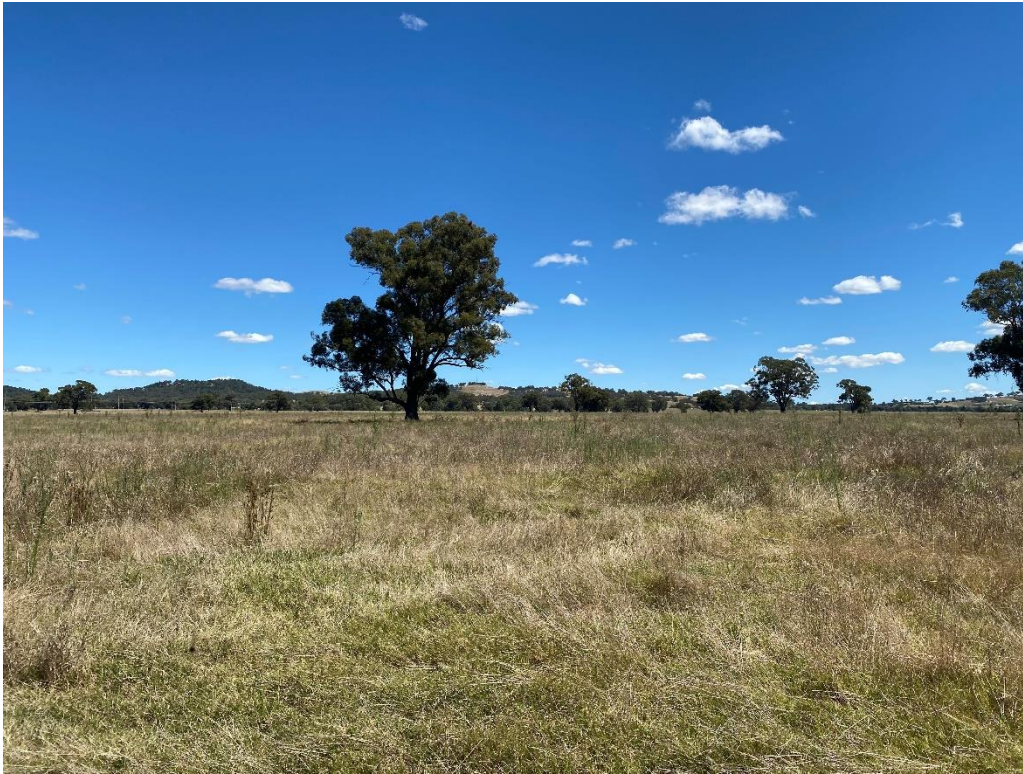
Figure 10: General view of the south-east portion of the site.

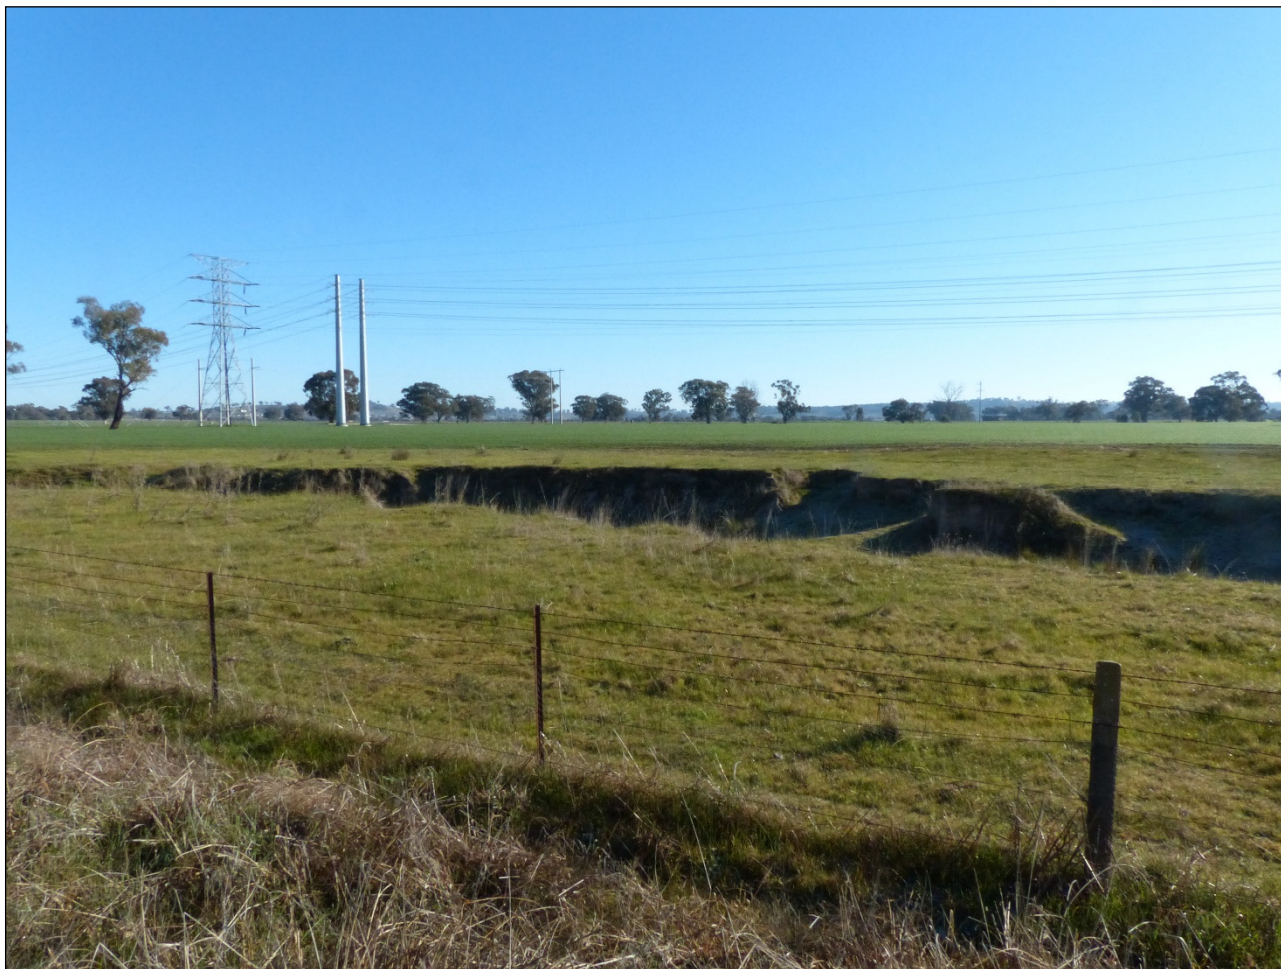
Landscape— very gently inclined long piedmont slopes. Local relief mostly <10 m; slope gradients <3%. Long undulating slopes and narrow drainage lines. Almost completely cleared tall woodland.

Soils— moderately deep (80 – 120 cm) Eutrophic Brown Chromosols on slopes, moderately deep (80 - 120 cm) Mottled Subnatric Brown Sodosols in drainage lines.

The Redbank soil group landscape is characterised by very gently inclined long piedmont slopes, local relief is less than 10 m and comprises of long undulating slopes and narrow drainage lines. The landscape is almost completely cleared of tall woodland. Limitations associated with the Redbank soil group include high erosion hazards, localised foundation hazards, localised water logging, strong acidity and low fertility soil.

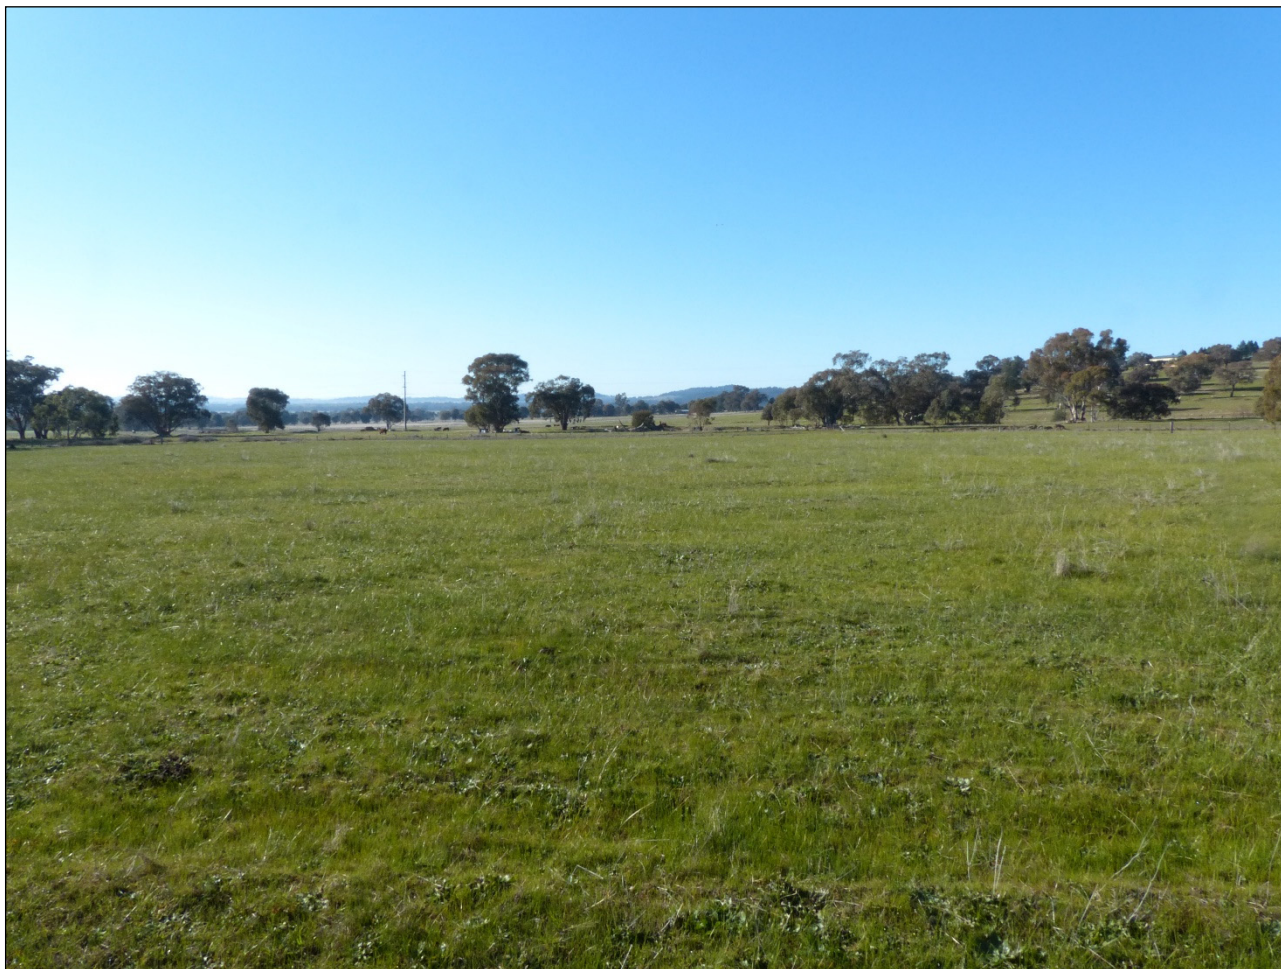
Landscape— gently inclined midslopes of adamellite and granite hills. Local relief 10 – 30 m; slope gradients 10 – 30%. Long slopes and mostly parallel shallow drainage lines. Rare rock outcrops. Almost completely cleared tall open-forest and woodland.

Landscape Variant— **gra**— similar to **gr** but with gentler slopes (<3%).

The Gregadoo variant a soil group landscape is characterised by gently inclined mid-slopes of adamellite and granite hills. Local relief ranges between 10 – 30 m and slope gradients are less than 3%. Long slopes and mostly parallel shallow drainage lines are present and rare rock outcrops are also associated with this soil landscape. Limitations associated with the Gregadoo variant a soil group include high erosion hazards, localised mass movement, localised foundation hazards, localised sodicity, strong acidity and low fertility soil with localised hardpans.

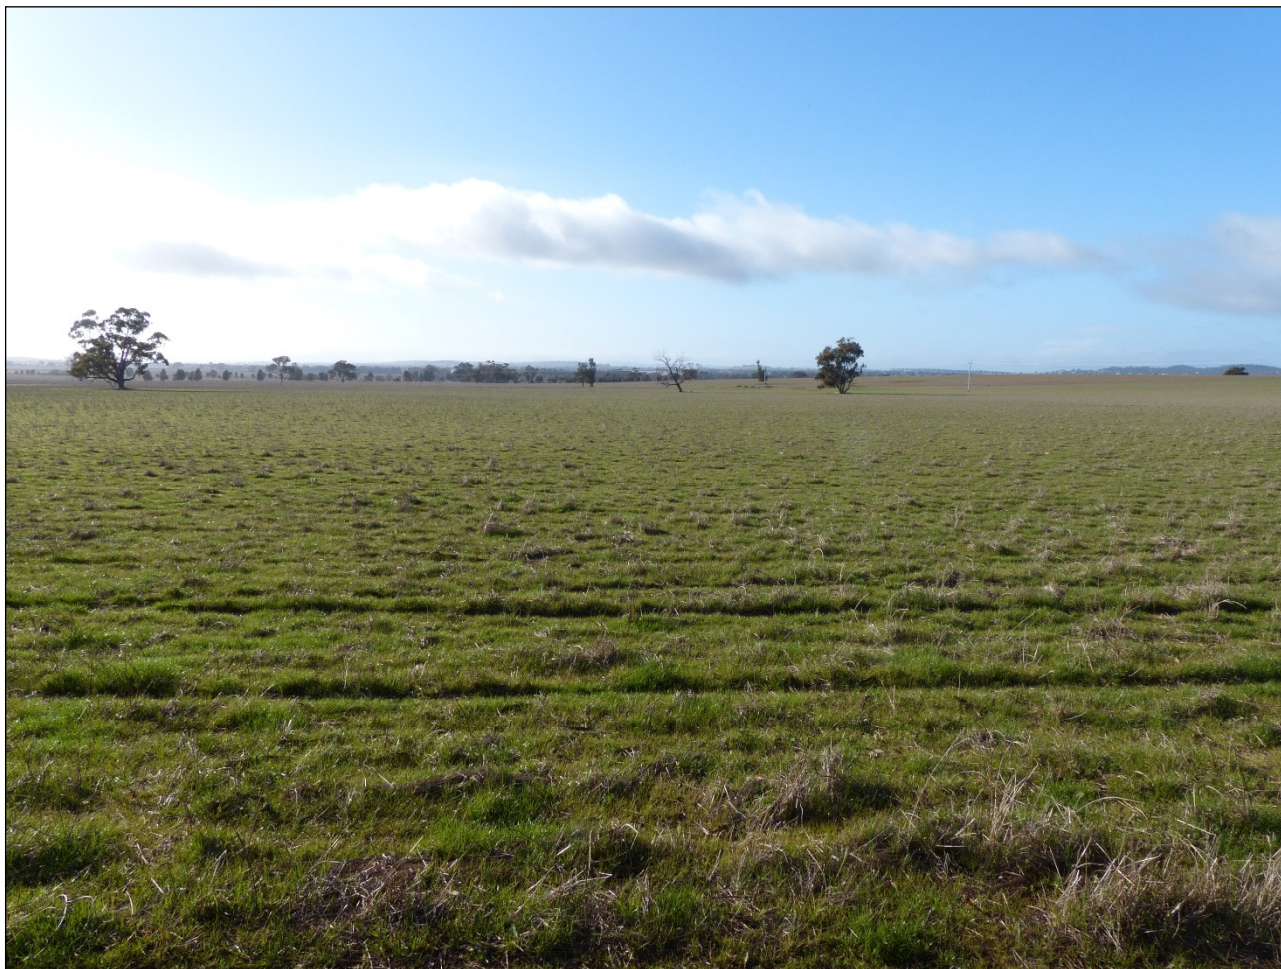
Landscape— gently inclined footslopes adjacent to hills of Ordovician metasedimentary rocks. Local relief 5 - 15 m; slope gradients 2 - 4%. Long (>300 m) waning slopes and mostly parallel, shallow drainage lines. Almost completely cleared tall woodland.

Landscape Variant— bka— similar to **bk** but in areas with convergent drainages, with higher run-on and higher erosion hazard.

The Becks Lane soil group landscape is characterised by gently inclined footslopes adjacent to hills of Ordovician metasedimentary rocks. Local relief ranges from 5 – 15 m and slope gradients are between 2 - 4%. Long (>300 m) waning slopes and mostly parallel, shallow drainage lines are present and the landscape is almost completely cleared of tall woodland. Limitations associated with the Becks Lane soil group include high erosion hazards, localised foundation hazards, acidity and locally hardsetting soil.
