**ARBORICULTURAL ASSESSMENT FOR  
DEVELOPMENT – 51 SIMMONS ST WAGGA WAGGA**

There is planned development for *Multi Dwelling Housing – 2 x two storey units to rear of existing dwelling, new single garage and associated tree removal works* at 51 Simmons Street Wagga Wagga. Wagga Wagga City Council development application DA20/0109 applies.

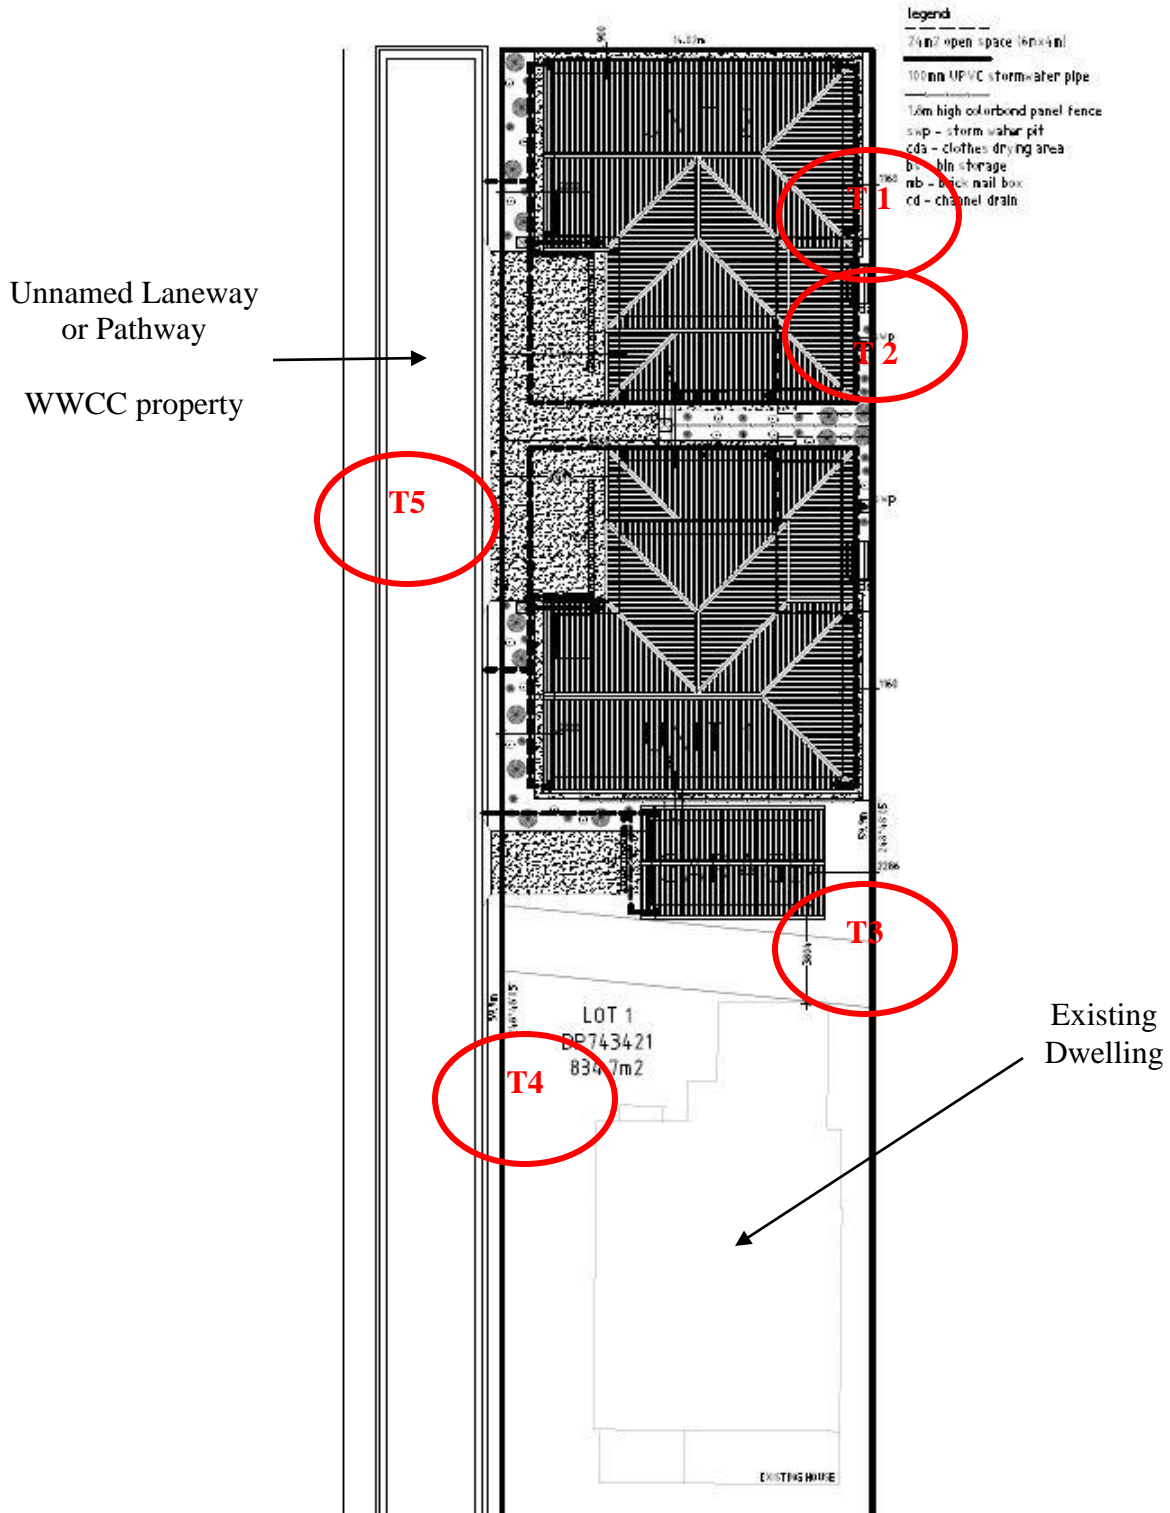
**Diagram 2 - Floor plan of the subject property**, with existing dwelling in the lower portion and the proposed units in the top portion. Unnamed laneway or pathway indicated to the left. Approximate location of the 5 trees have been added as indicated – relative to the proposed development. Source - Adapted from Jones Design.

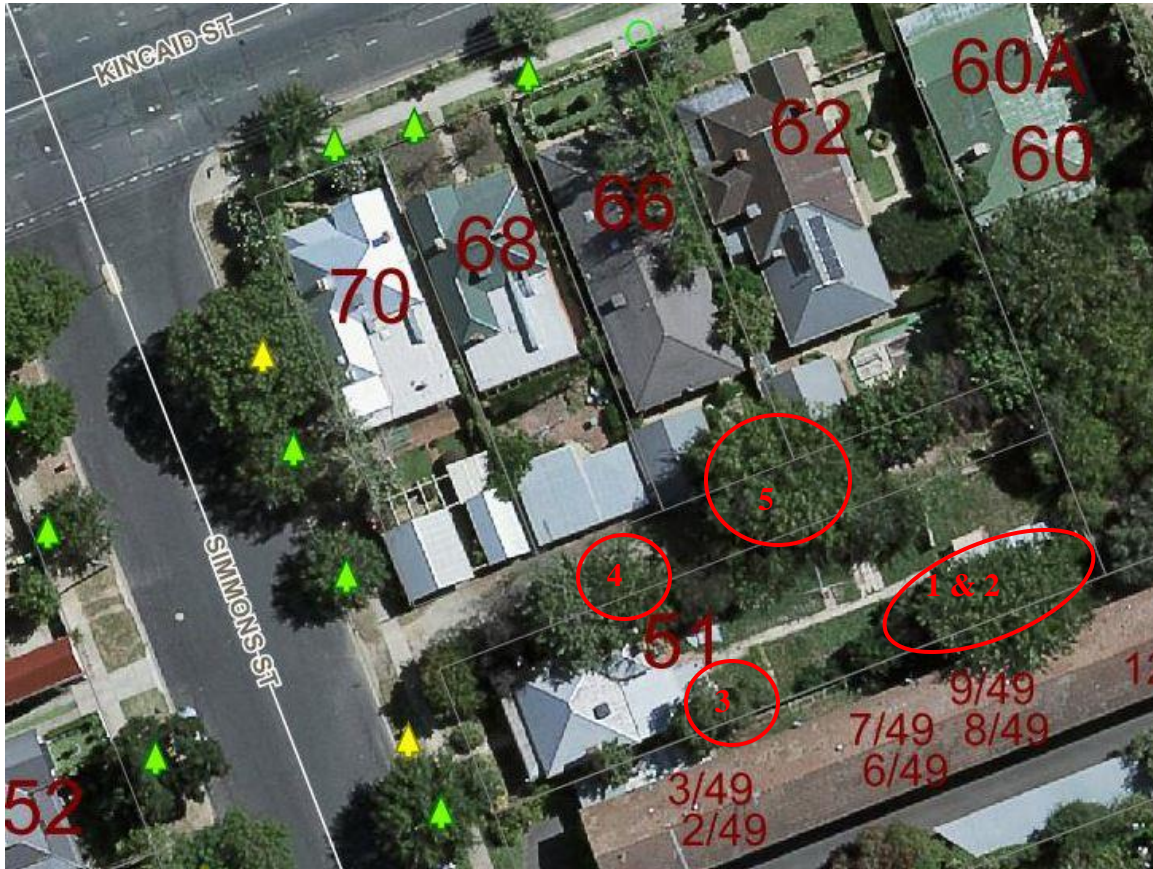
**Diagram 3 – Aerial view of the property and the 5 subject trees have been identified.** Source WWCC Intramaps 2020.

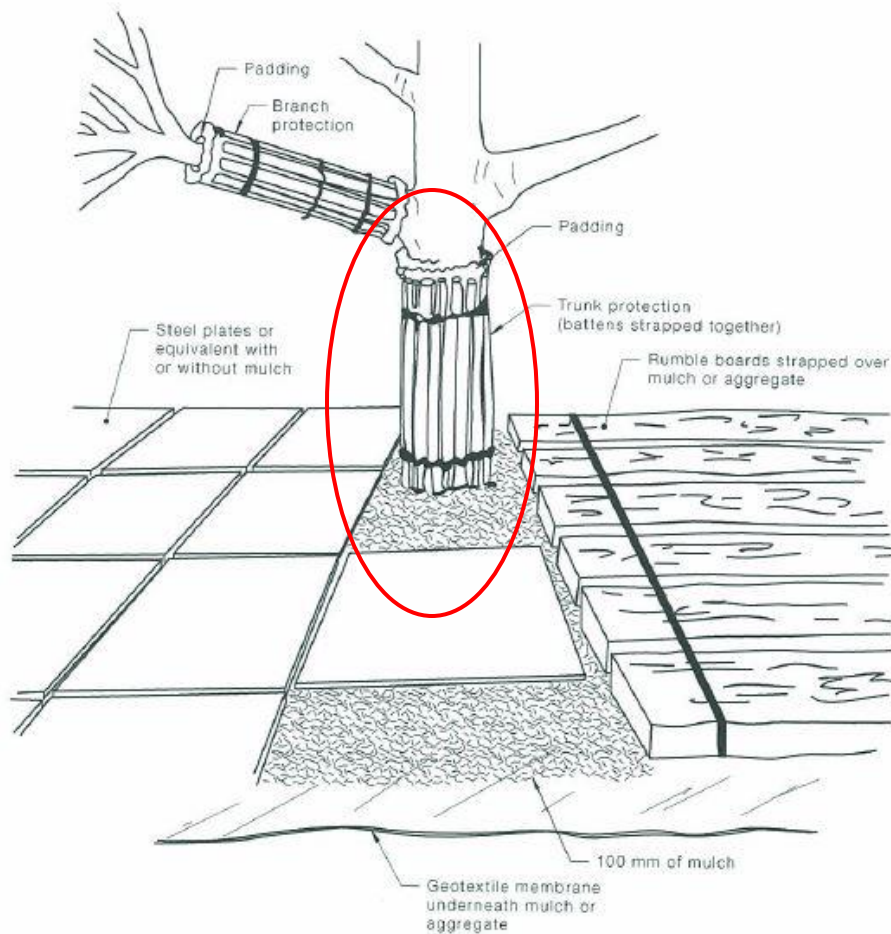
**Diagram 4 – Extract from AS 4370- Protection of Trees on Development sites.**

Physical protection should be fitted to the south stem of Tree 5 – whereby timber slats should be installed to prevent damage to the stem from any vehicle or plant impacts. As noted – the timber is not to be screwed or nailed to the stem it needs to be fitted so that no damage occurs to the tree and it can be removed at completion of the development. If further advice is required on how this can be practically installed please contact the author for further instructions.
