WAGGA WAGGA CITY COUNCIL

MANGOPLAH AND HUMULA FLOOD STUDY

MILESTONE 1 REPORT

OCTOBER 2024

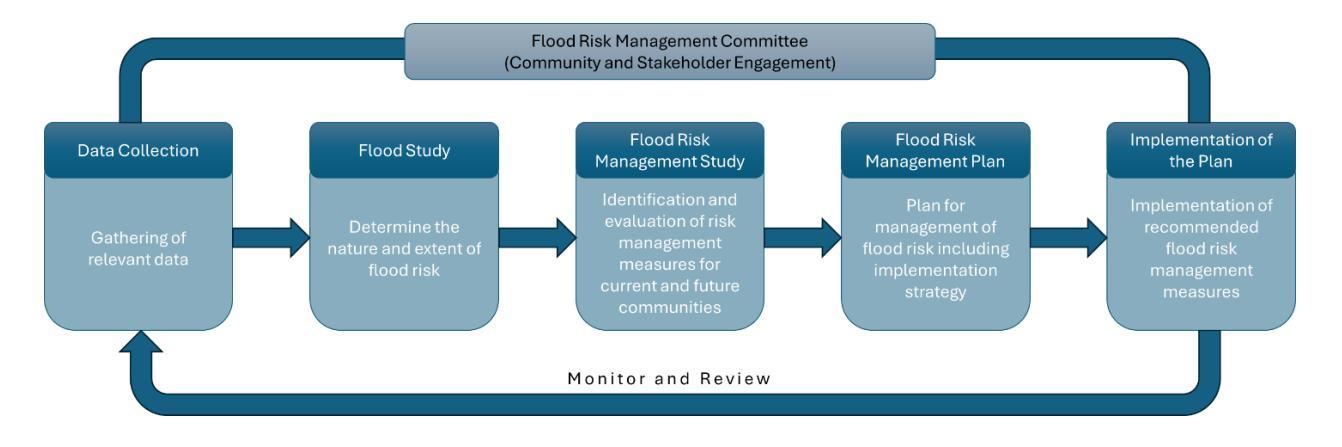
The Policy provides for technical and financial support by the Government through five sequential stages:

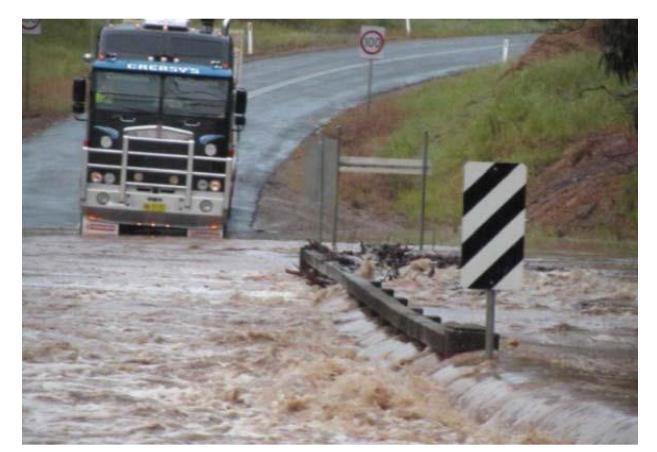
Photo 2: Holbrook Road Bridge (15th Oct, 5:30pm)

During the event, Holbrook Road Bridge on Burkes Creek in Mangoplah was closed at 5pm on the 15th October 2010 and remained closed for a week. By 8:30pm on the same day, the creek rose above the concrete guard rails of the bridge. This was the highest flood level observed at the bridge in recent history. No other information about the interaction of the event with the community is available.

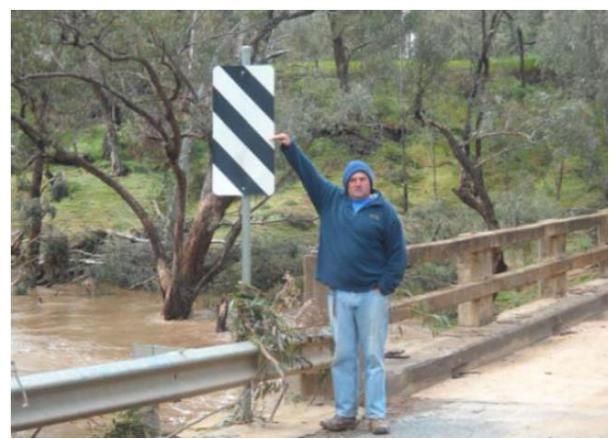
Photo 1: Esitmated Peak Flood Height

Mangoplah is impacted by local overland flow and mainstream flooding from Burkes Creek and Paper Forest Creek. Some parts of the study area, lying diagonally through the town are elevated above the rest of the town which results in these regions being at a lower risk of mainstream flooding. Flooding to the north of the elevated areas is impacted by Burkes Creek while the areas to the south are impacted by Paper Forest Creek. The Holbrook Road bridge is one of the worst impacted locations within the study area. In the October 2010 event, the bridge was flooded above the concrete rails.

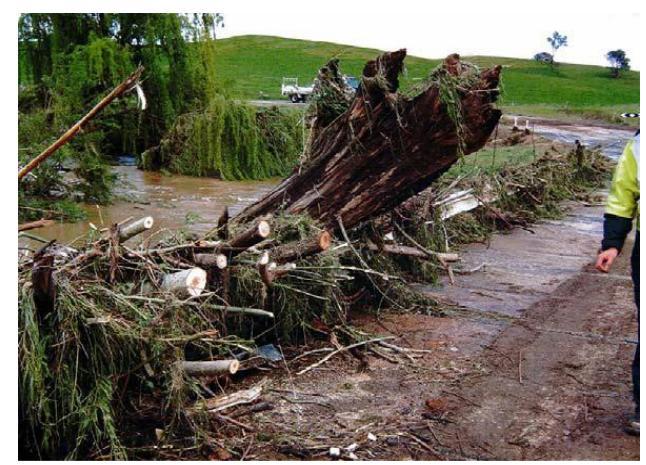
Photo 3: Carabost Creek Bridge

Umbango Creek Bridge and Carabost Creek Bridge at Eight Mile Road were damaged during the event. Debris were deposited at the Humula Eight Mile Road. Humula Citizens Sports Club was also flooded. Information on the observed flood levels and the properties flooded is not available. Some photos from the event are provided below.

The document provides photos and information on the flood levels at the Holbrook Road Bridge within Mangoplah. Some information on the damages that occurred at Carabost Bridge and Umbango Creek Bridge within Humula have also been provided. Rainfall gauges at both the towns were analysed.

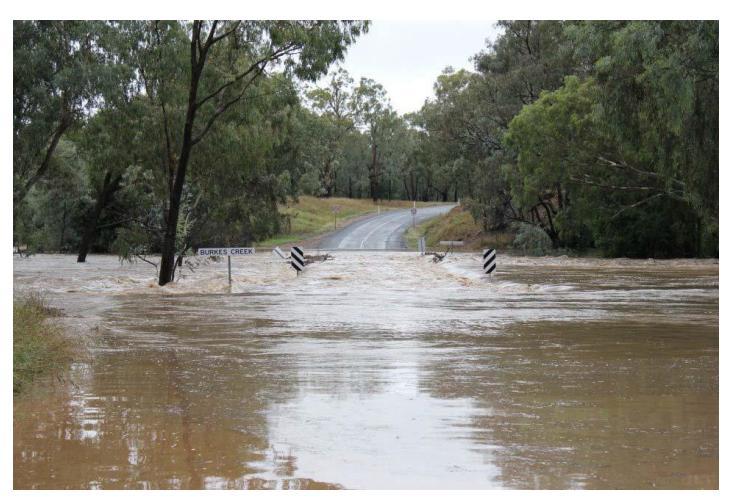
Photo 6: Holbrook Road Bridge (4th Mar, 9am)

Holbrook Road Bridge in Mangoplah was flooded during this event however the flood level was estimated to be 0.4m below the October 2010 event. Substantially higher flow from Paper Forest Creek was observed during the March 2012 event. No other information describing the impact of the event within Humula and Mangoplah could be located.
