FIGURE 1
PEAK FLOOD DEPTHS
5% AEP EVENT

58 Plumpton Road, Lake Albert

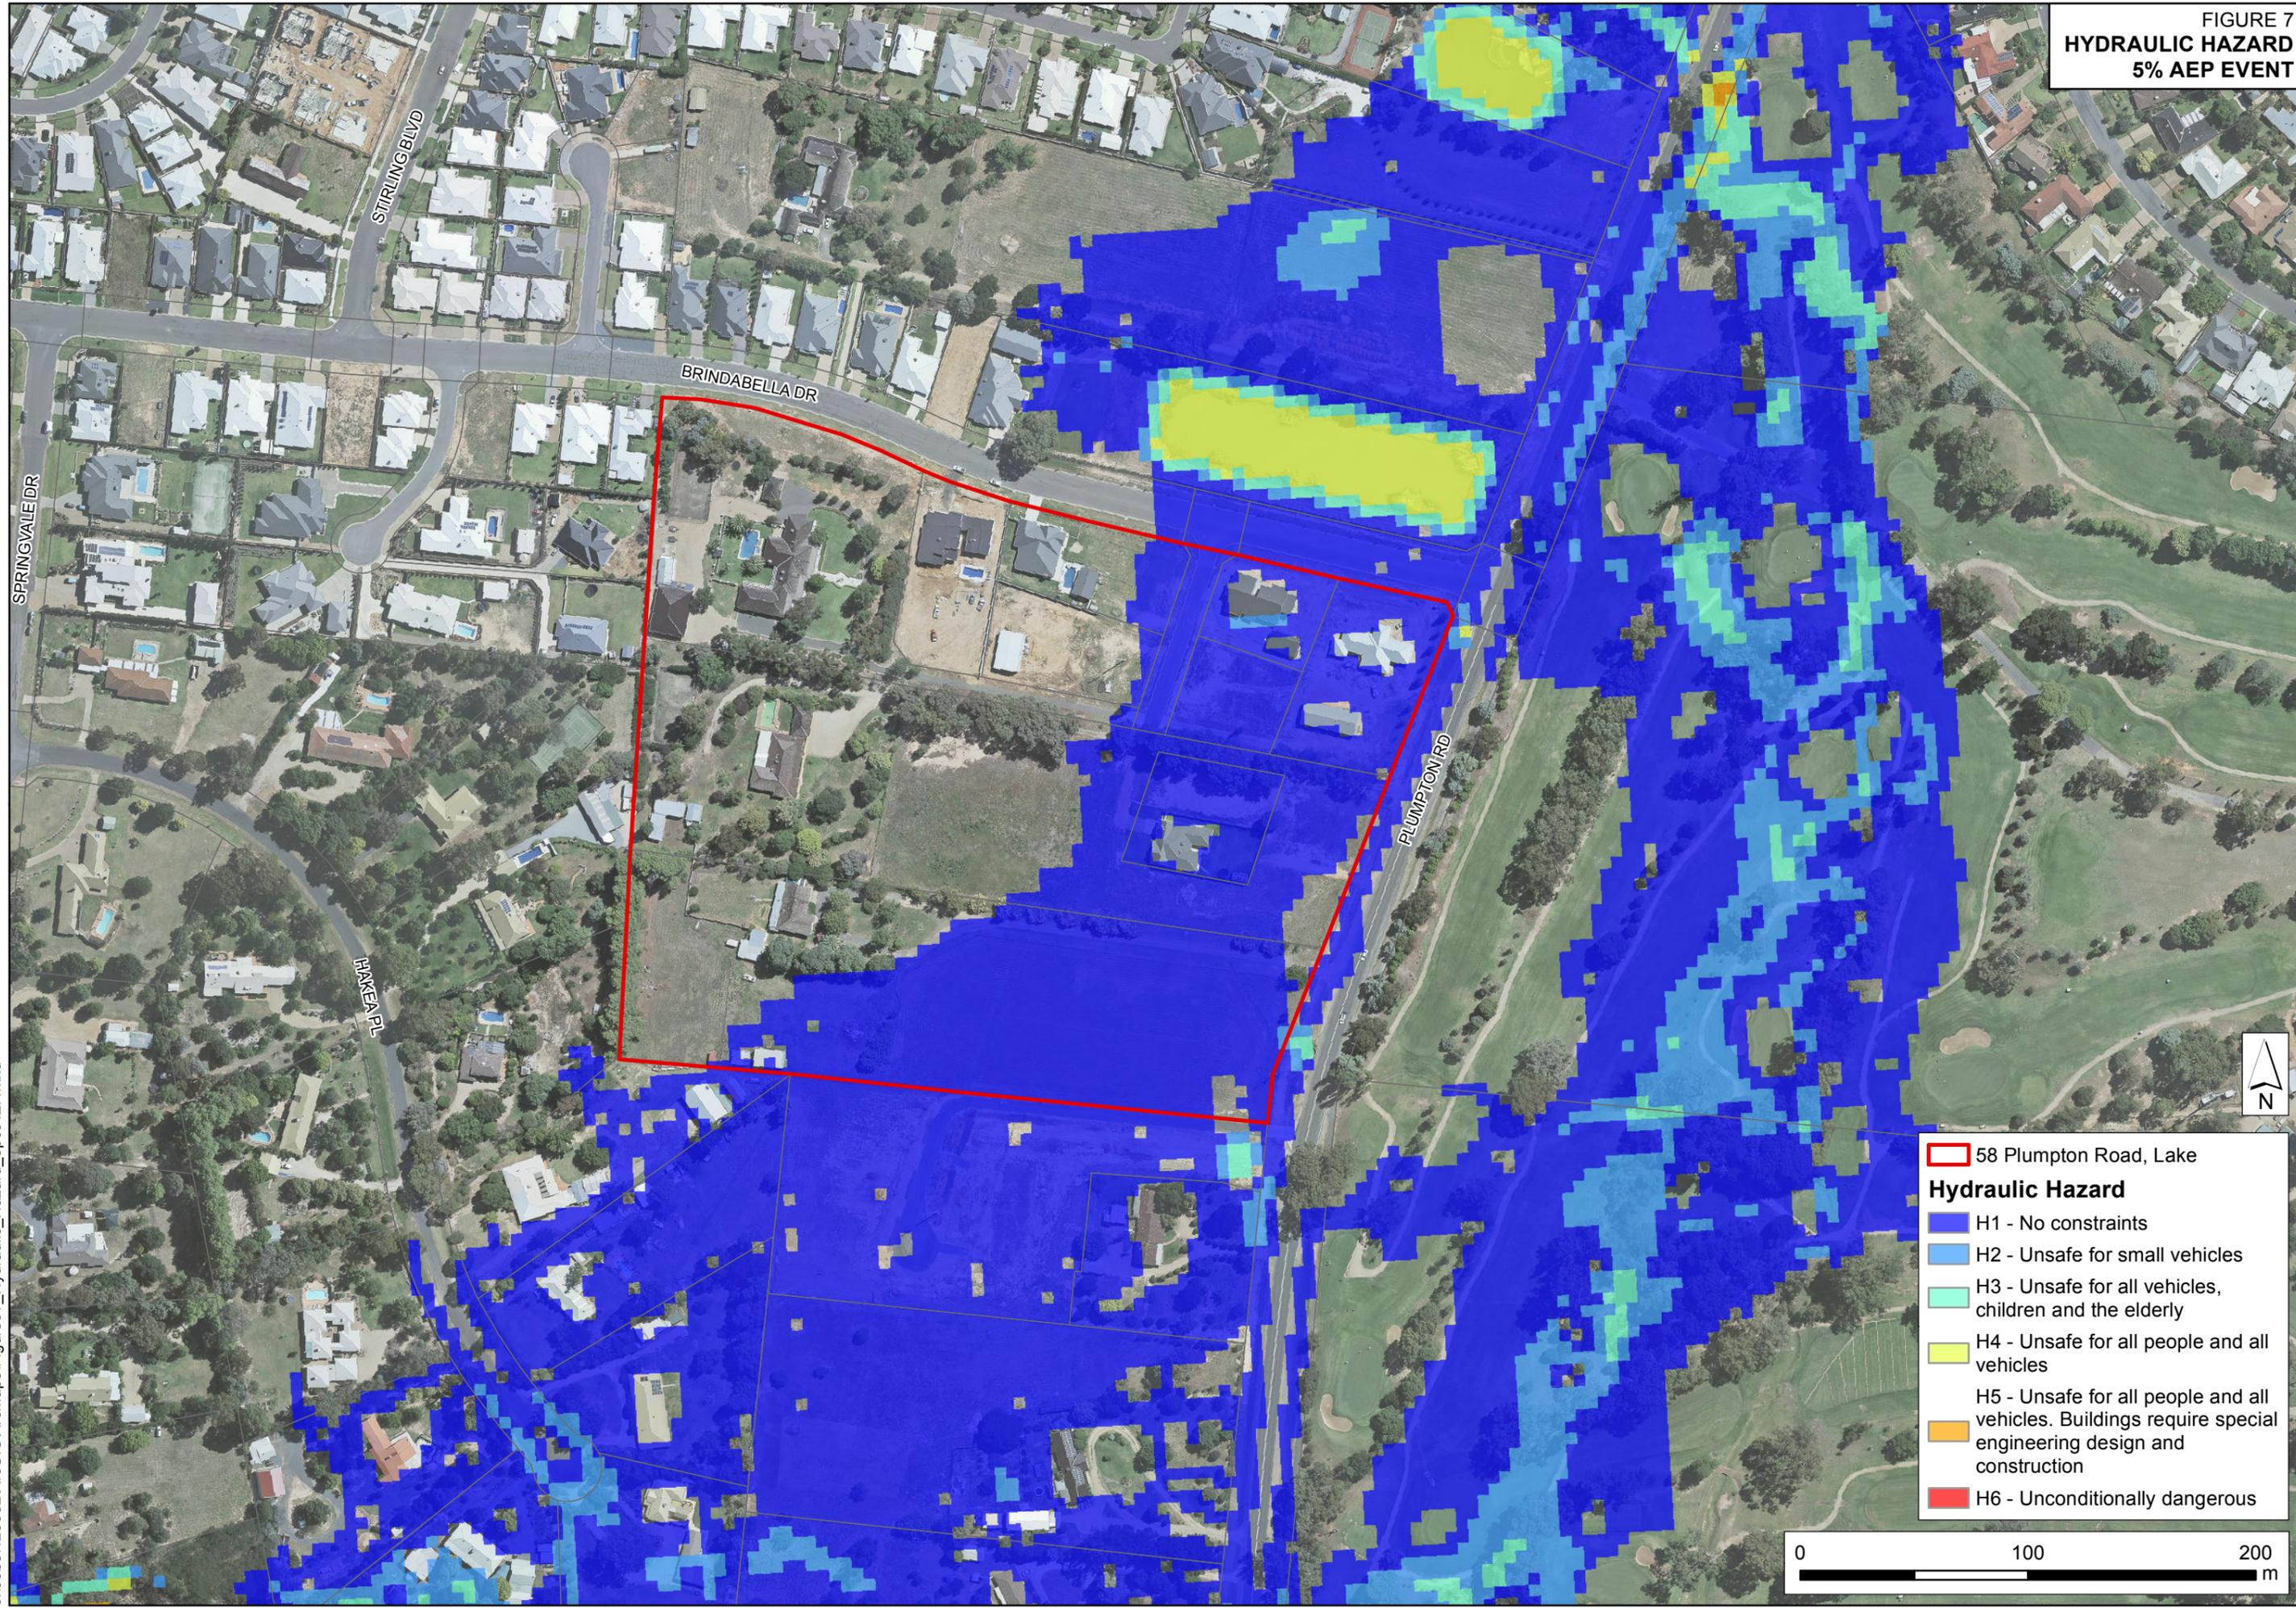
FIGURE 7
HYDRAULIC HAZARD
5% AEP EVENT

Hydraulic Hazard

H1 - No constraints
-

H2 - Unsafe for small vehicles
-

H3 - Unsafe for all vehicles, children and the elderly
-

H4 - Unsafe for all people and all vehicles
-

H5 - Unsafe for all people and all vehicles. Buildings require special engineering design and construction
-

H6 - Unconditionally dangerous

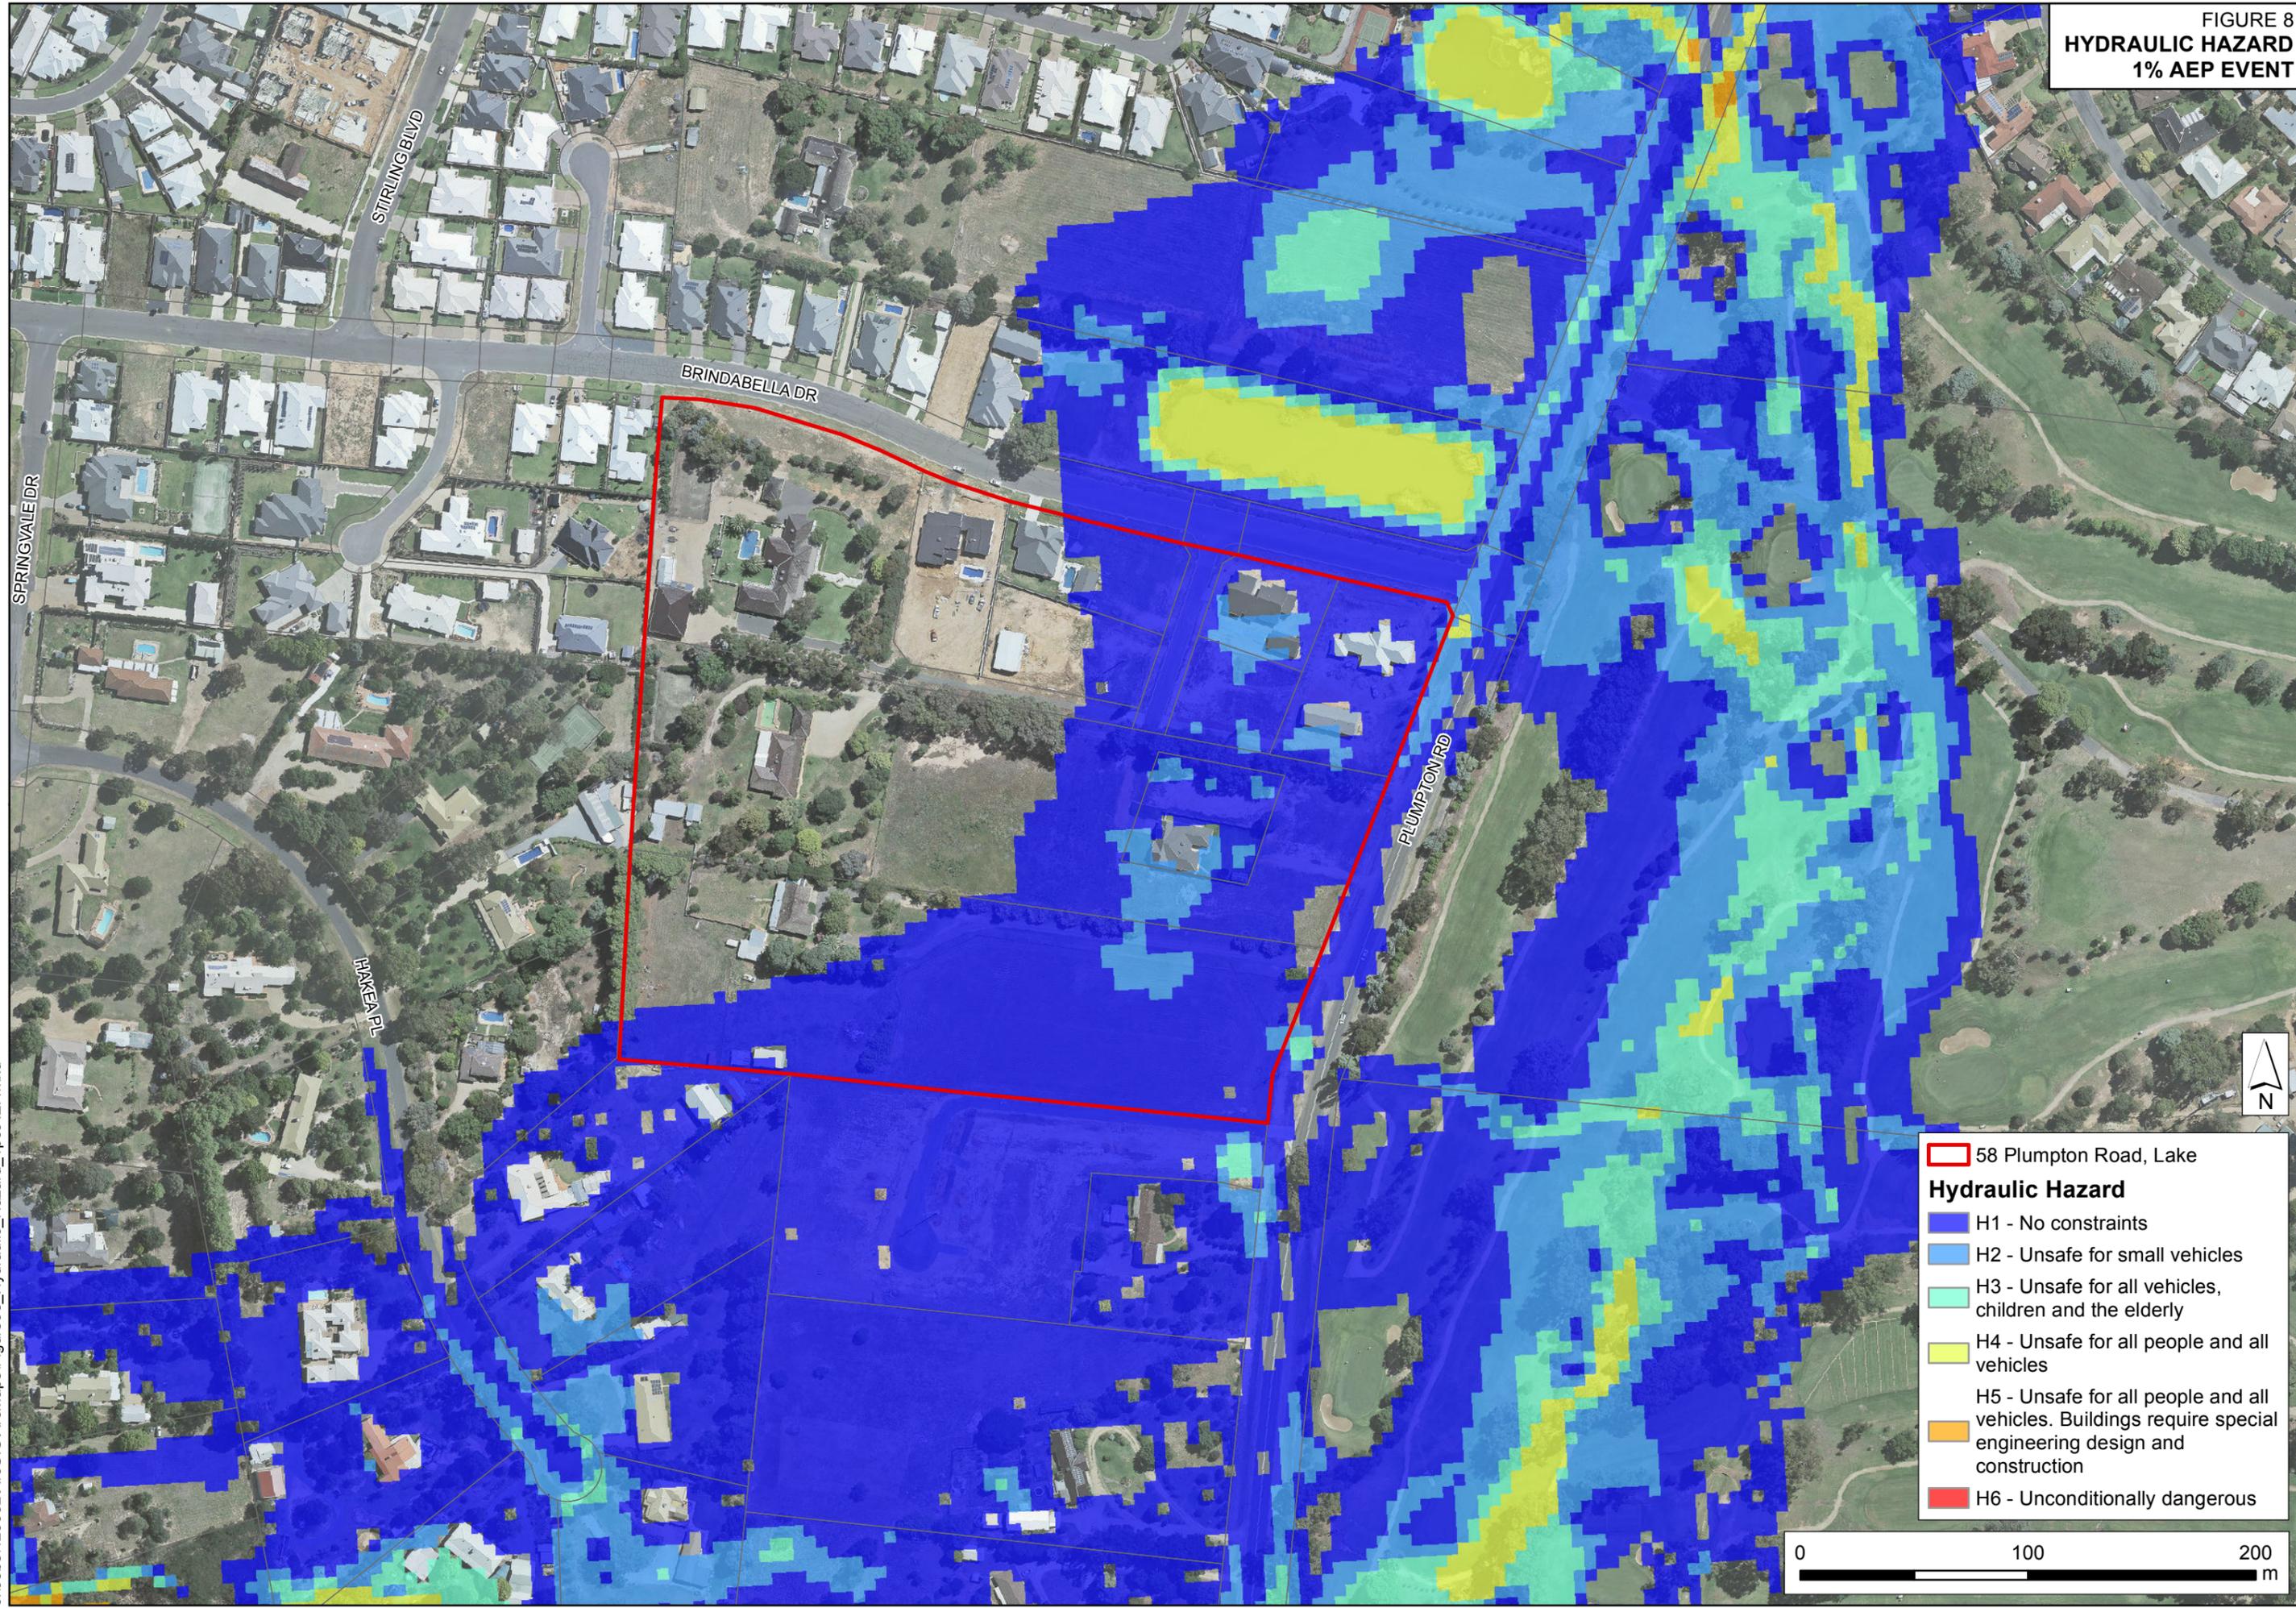
FIGURE 8
HYDRAULIC HAZARD
1% AEP EVENT

Hydraulic Hazard

H1 - No constraints
-

H2 - Unsafe for small vehicles
-

H3 - Unsafe for all vehicles, children and the elderly
-

H4 - Unsafe for all people and all vehicles
-

H5 - Unsafe for all people and all vehicles. Buildings require special engineering design and construction
-

H6 - Unconditionally dangerous

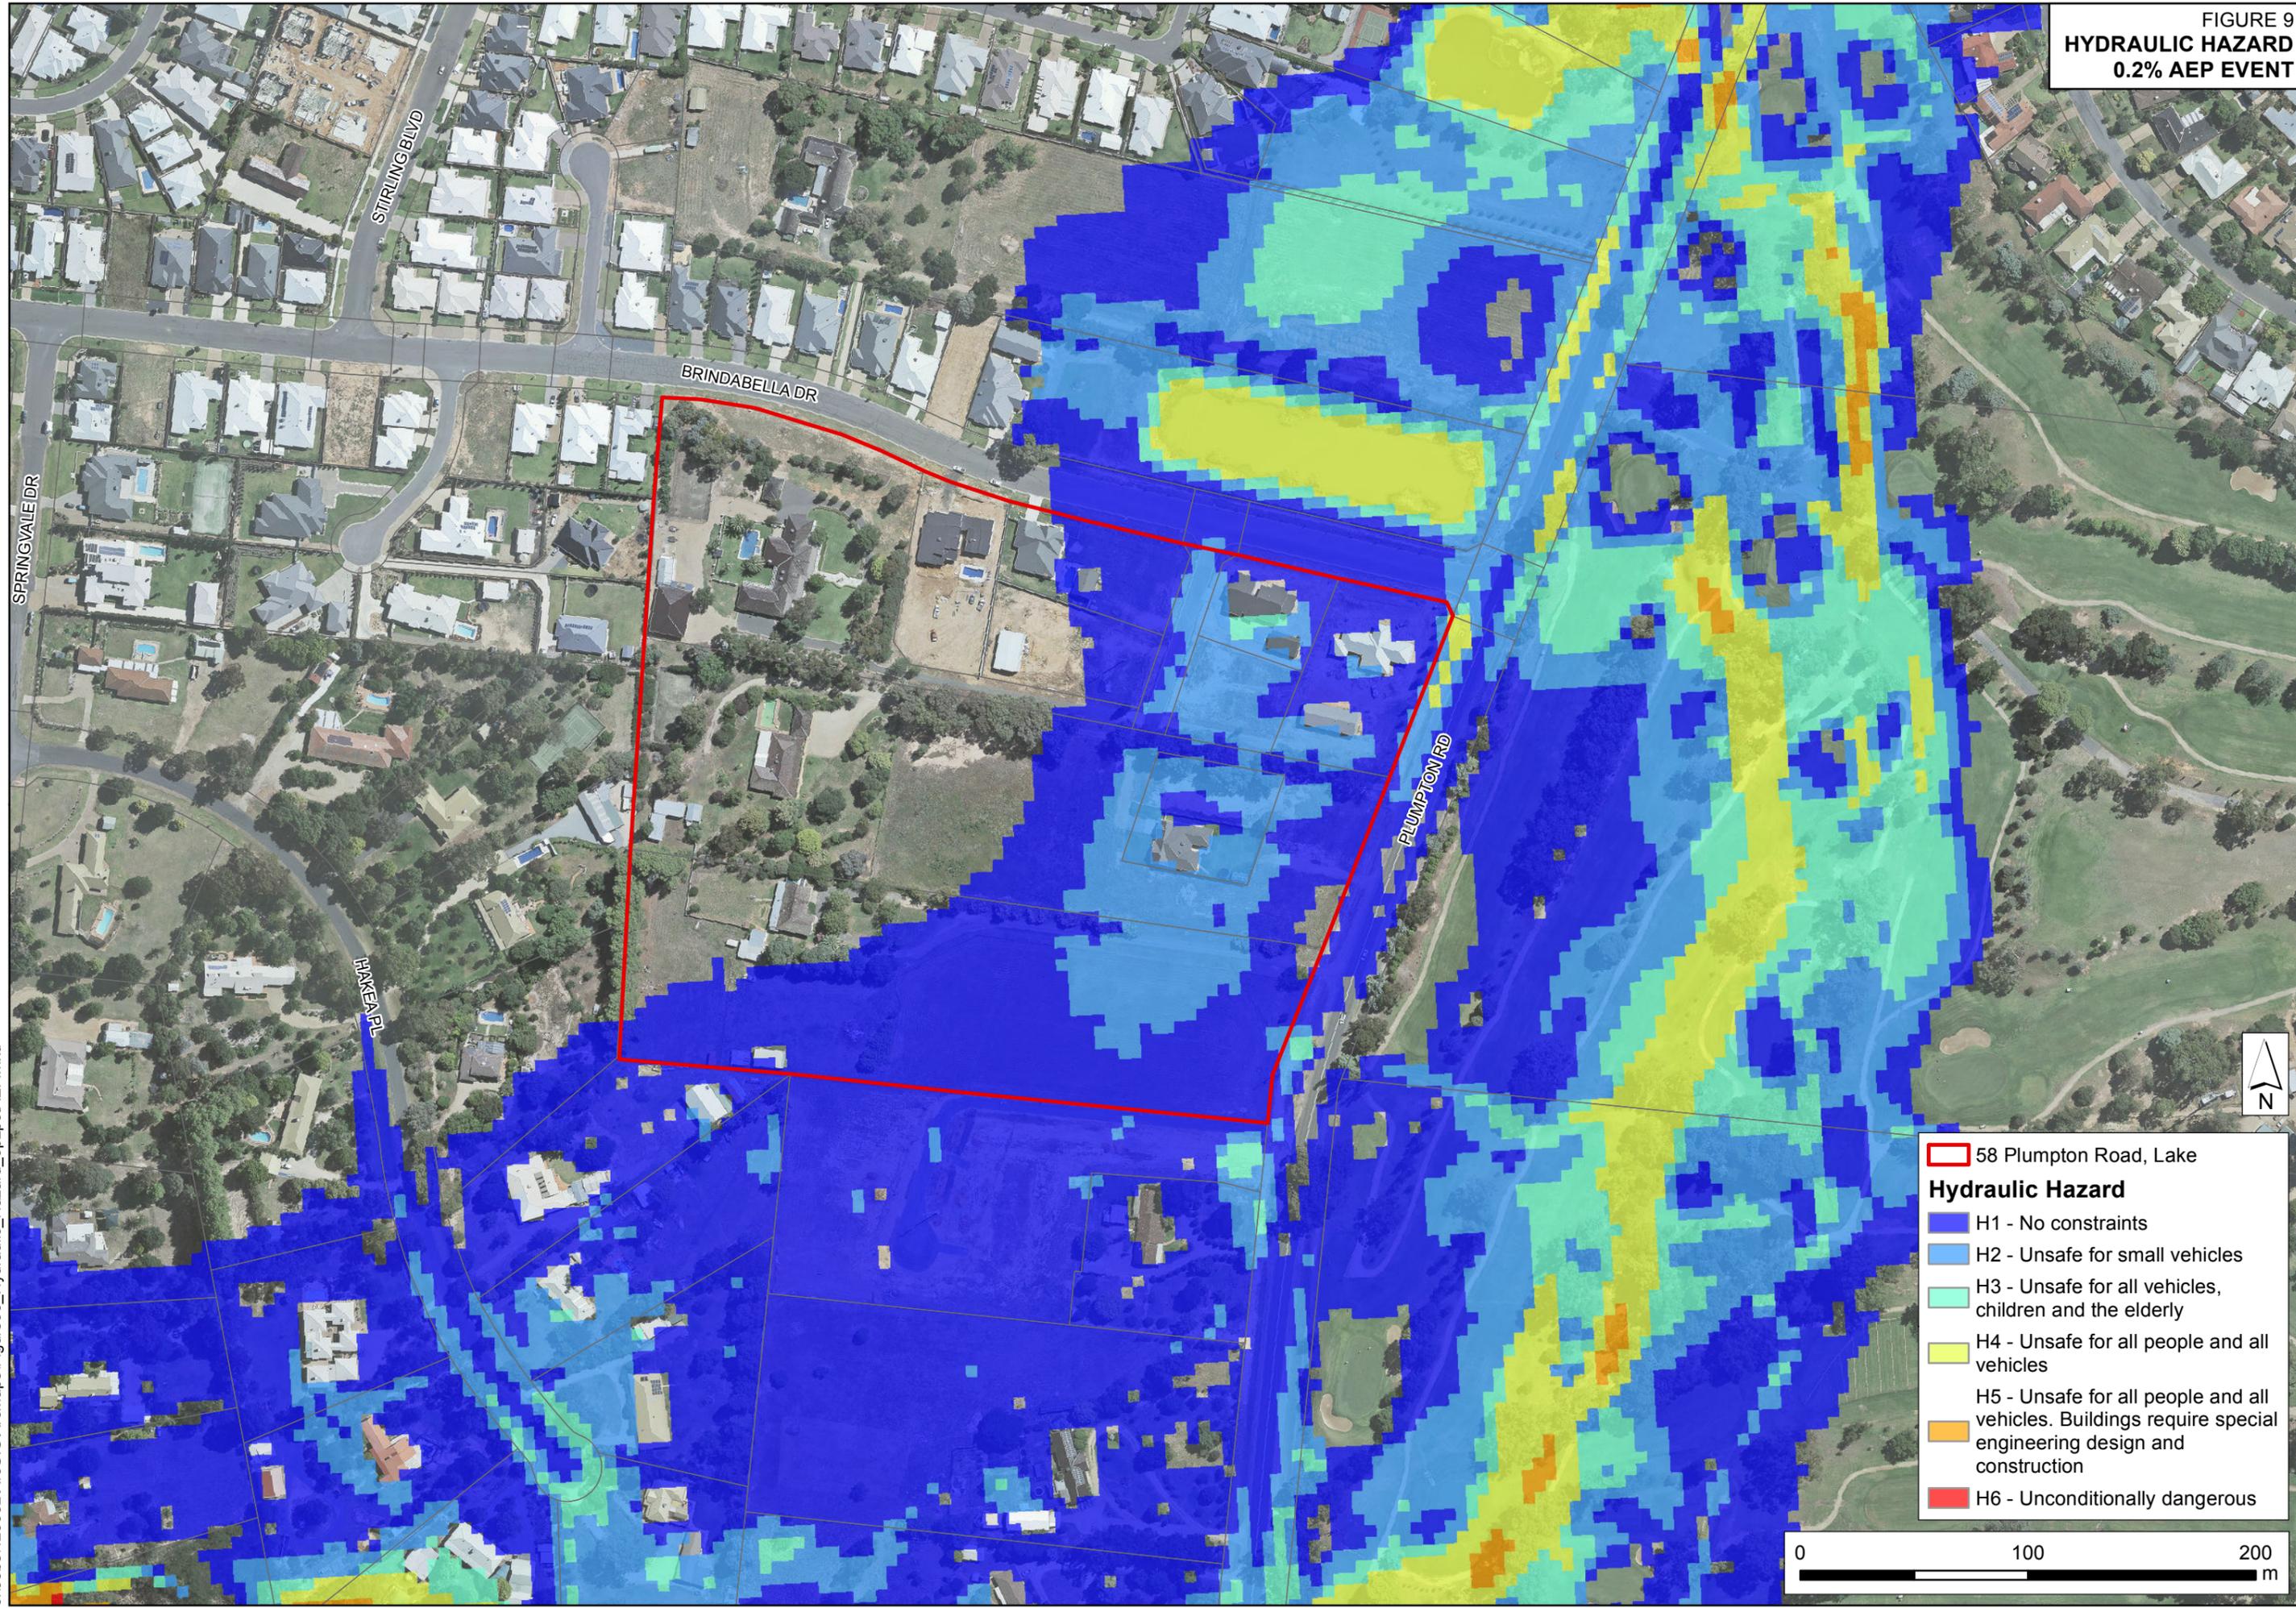
FIGURE 9
HYDRAULIC HAZARD
0.2% AEP EVENT

Hydraulic Hazard

H1 - No constraints
-

H2 - Unsafe for small vehicles
-

H3 - Unsafe for all vehicles, children and the elderly
-

H4 - Unsafe for all people and all vehicles
-

H5 - Unsafe for all people and all vehicles. Buildings require special engineering design and construction
-

H6 - Unconditionally dangerous

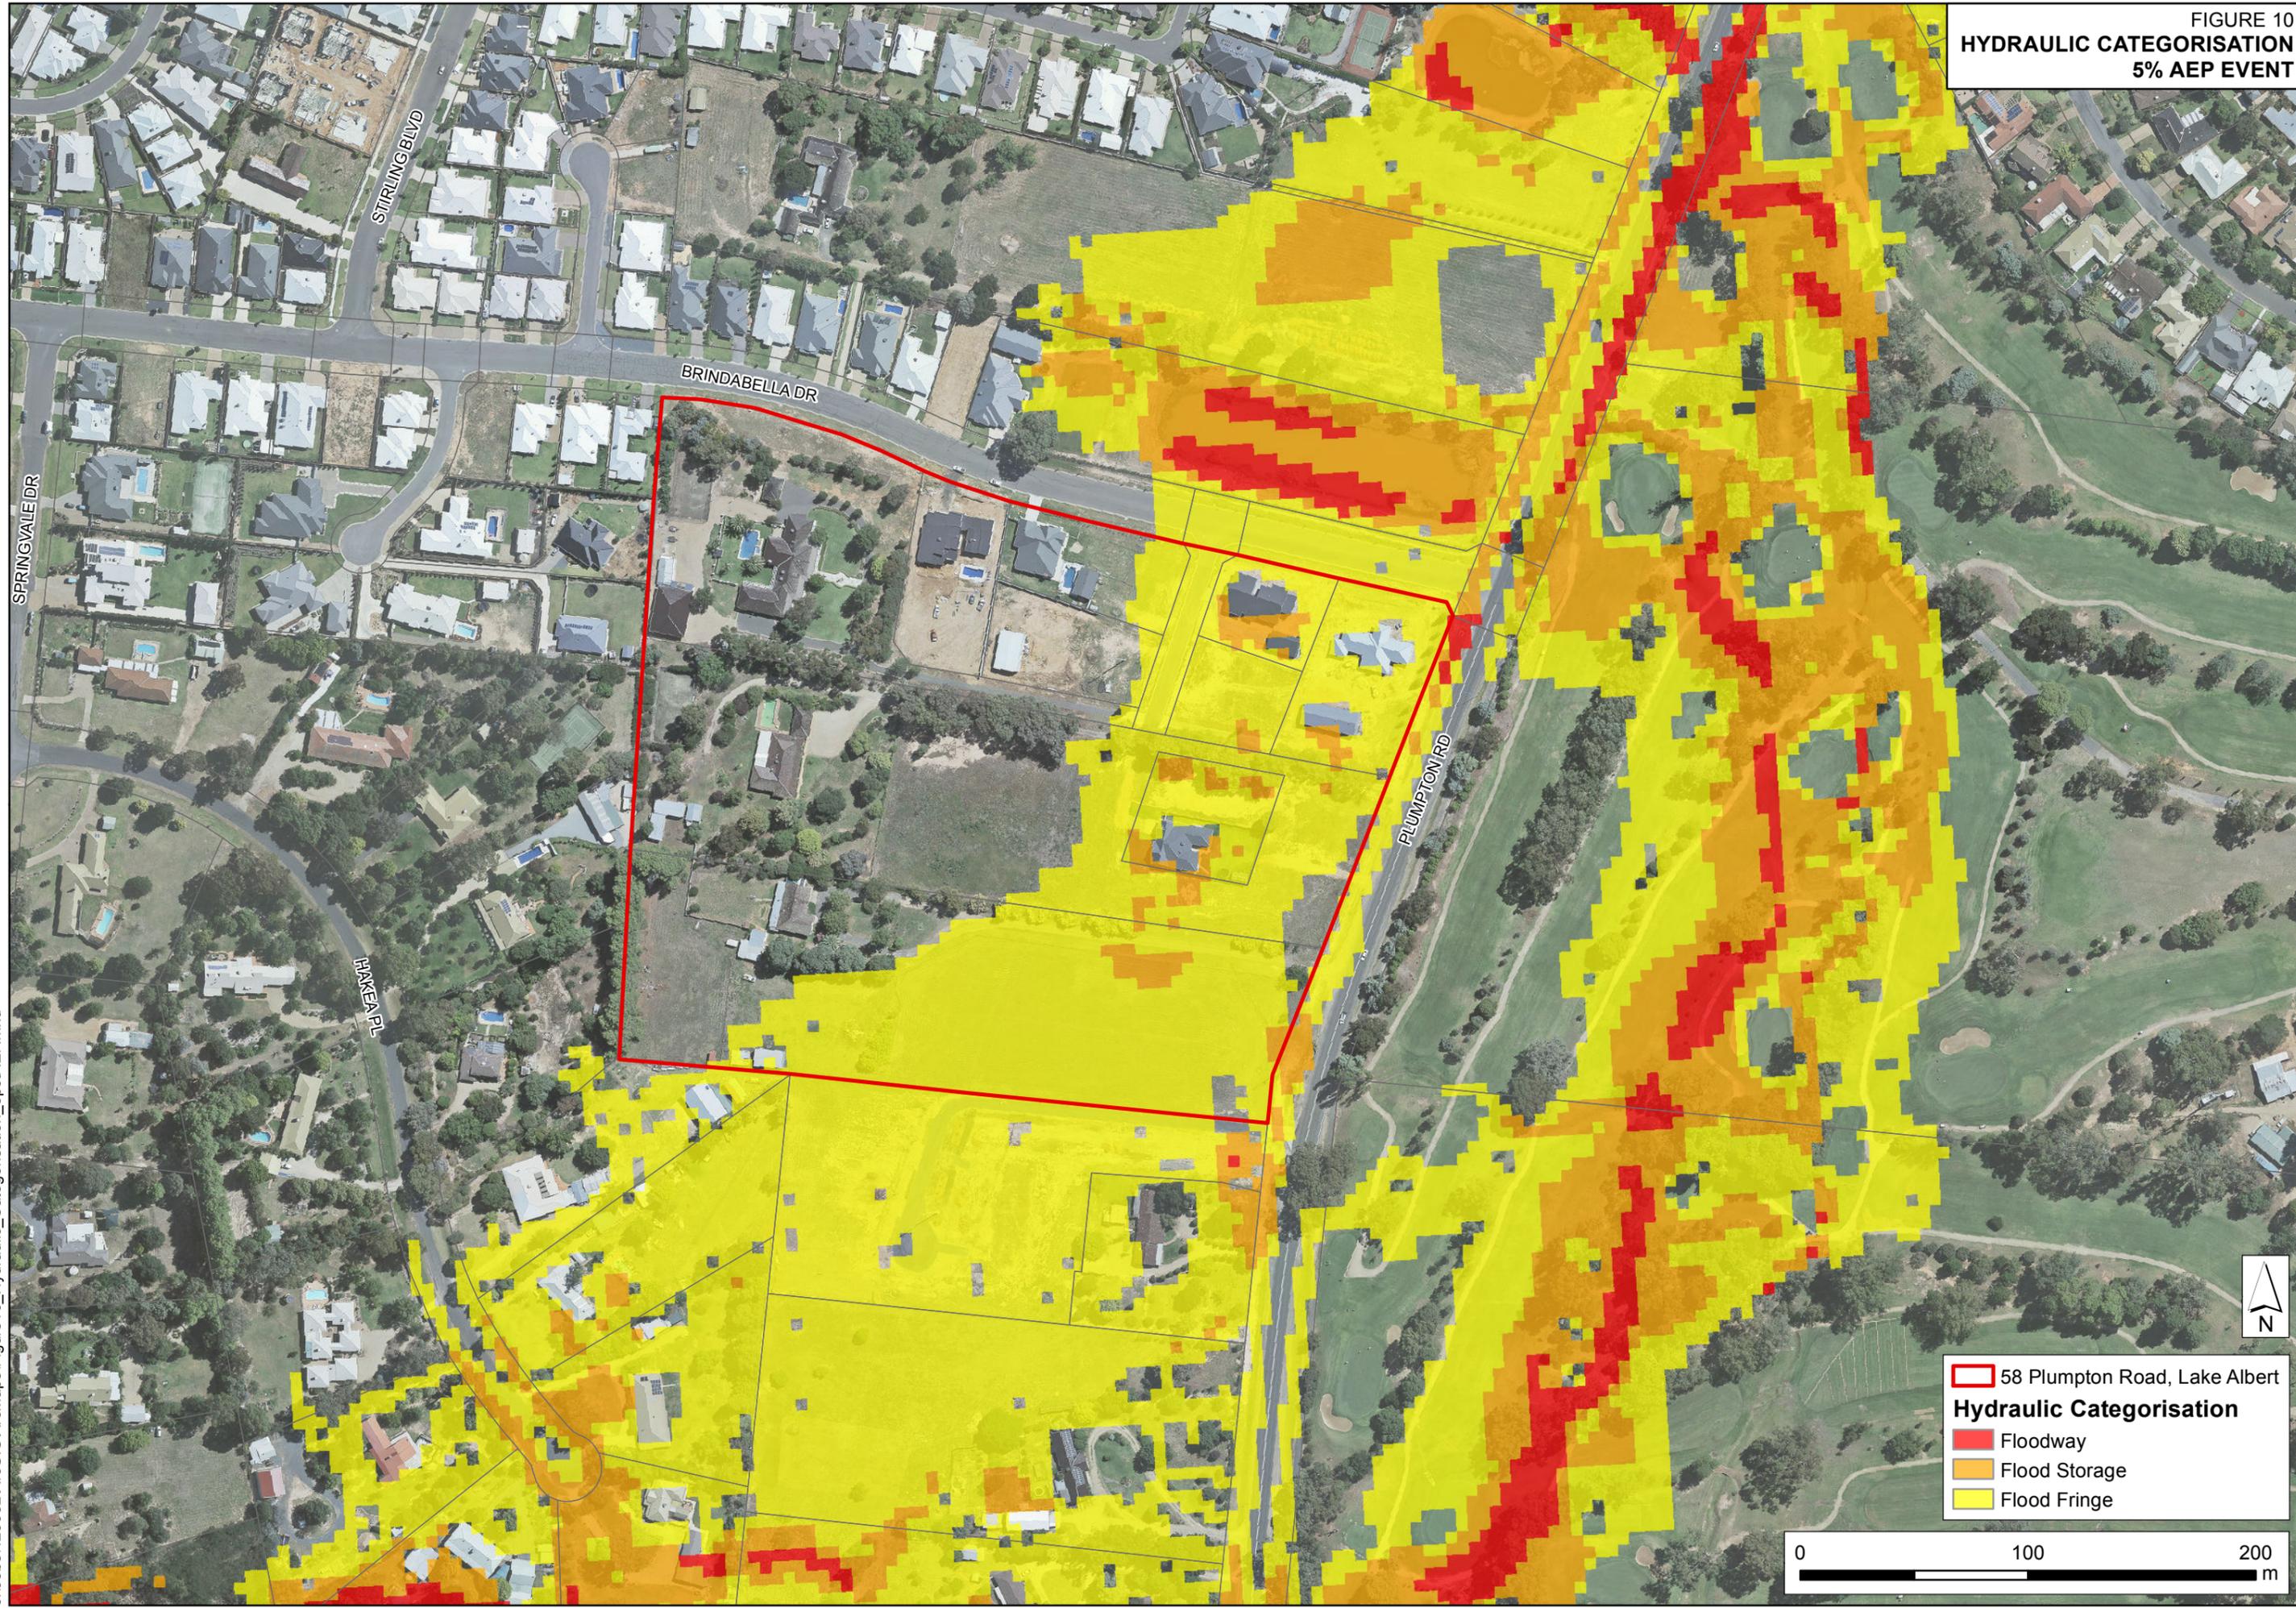
FIGURE 10
HYDRAULIC CATEGORISATION
5% AEP EVENT

Hydraulic Categorisation

- Floodway
- Flood Storage
- Flood Fringe

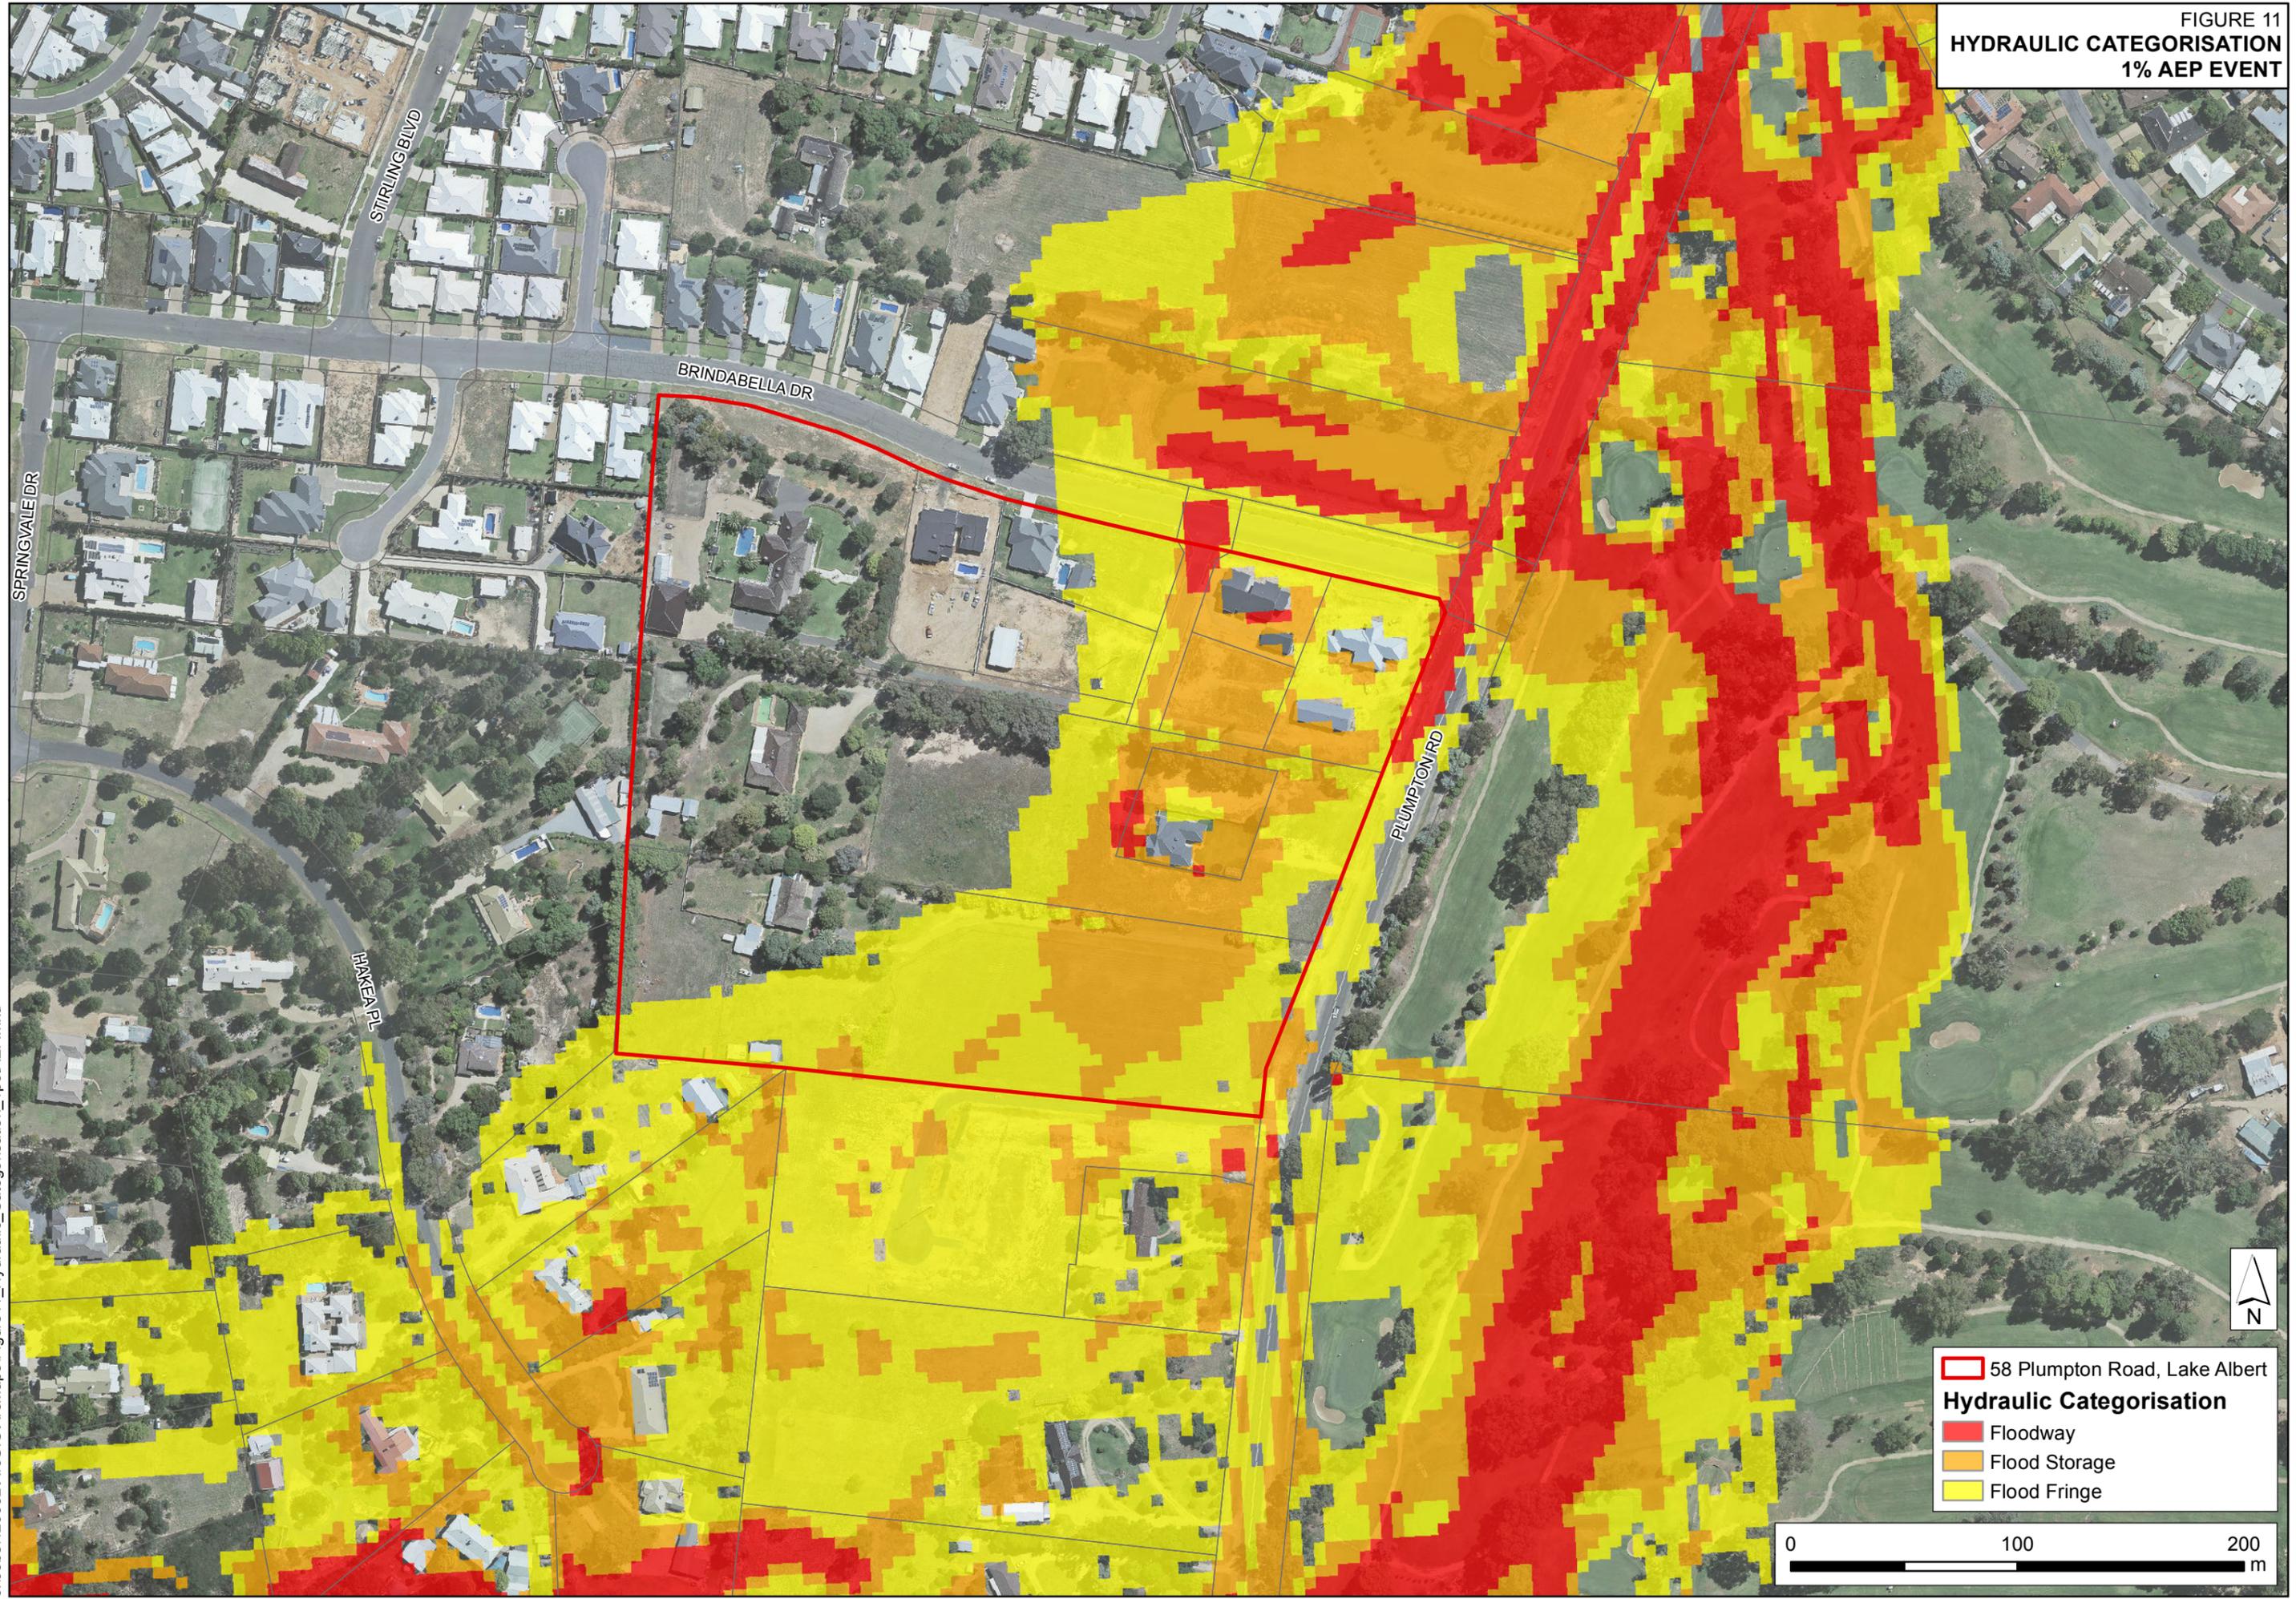
FIGURE 11
HYDRAULIC CATEGORISATION
1% AEP EVENT

Hydraulic Categorisation

- Floodway
- Flood Storage
- Flood Fringe

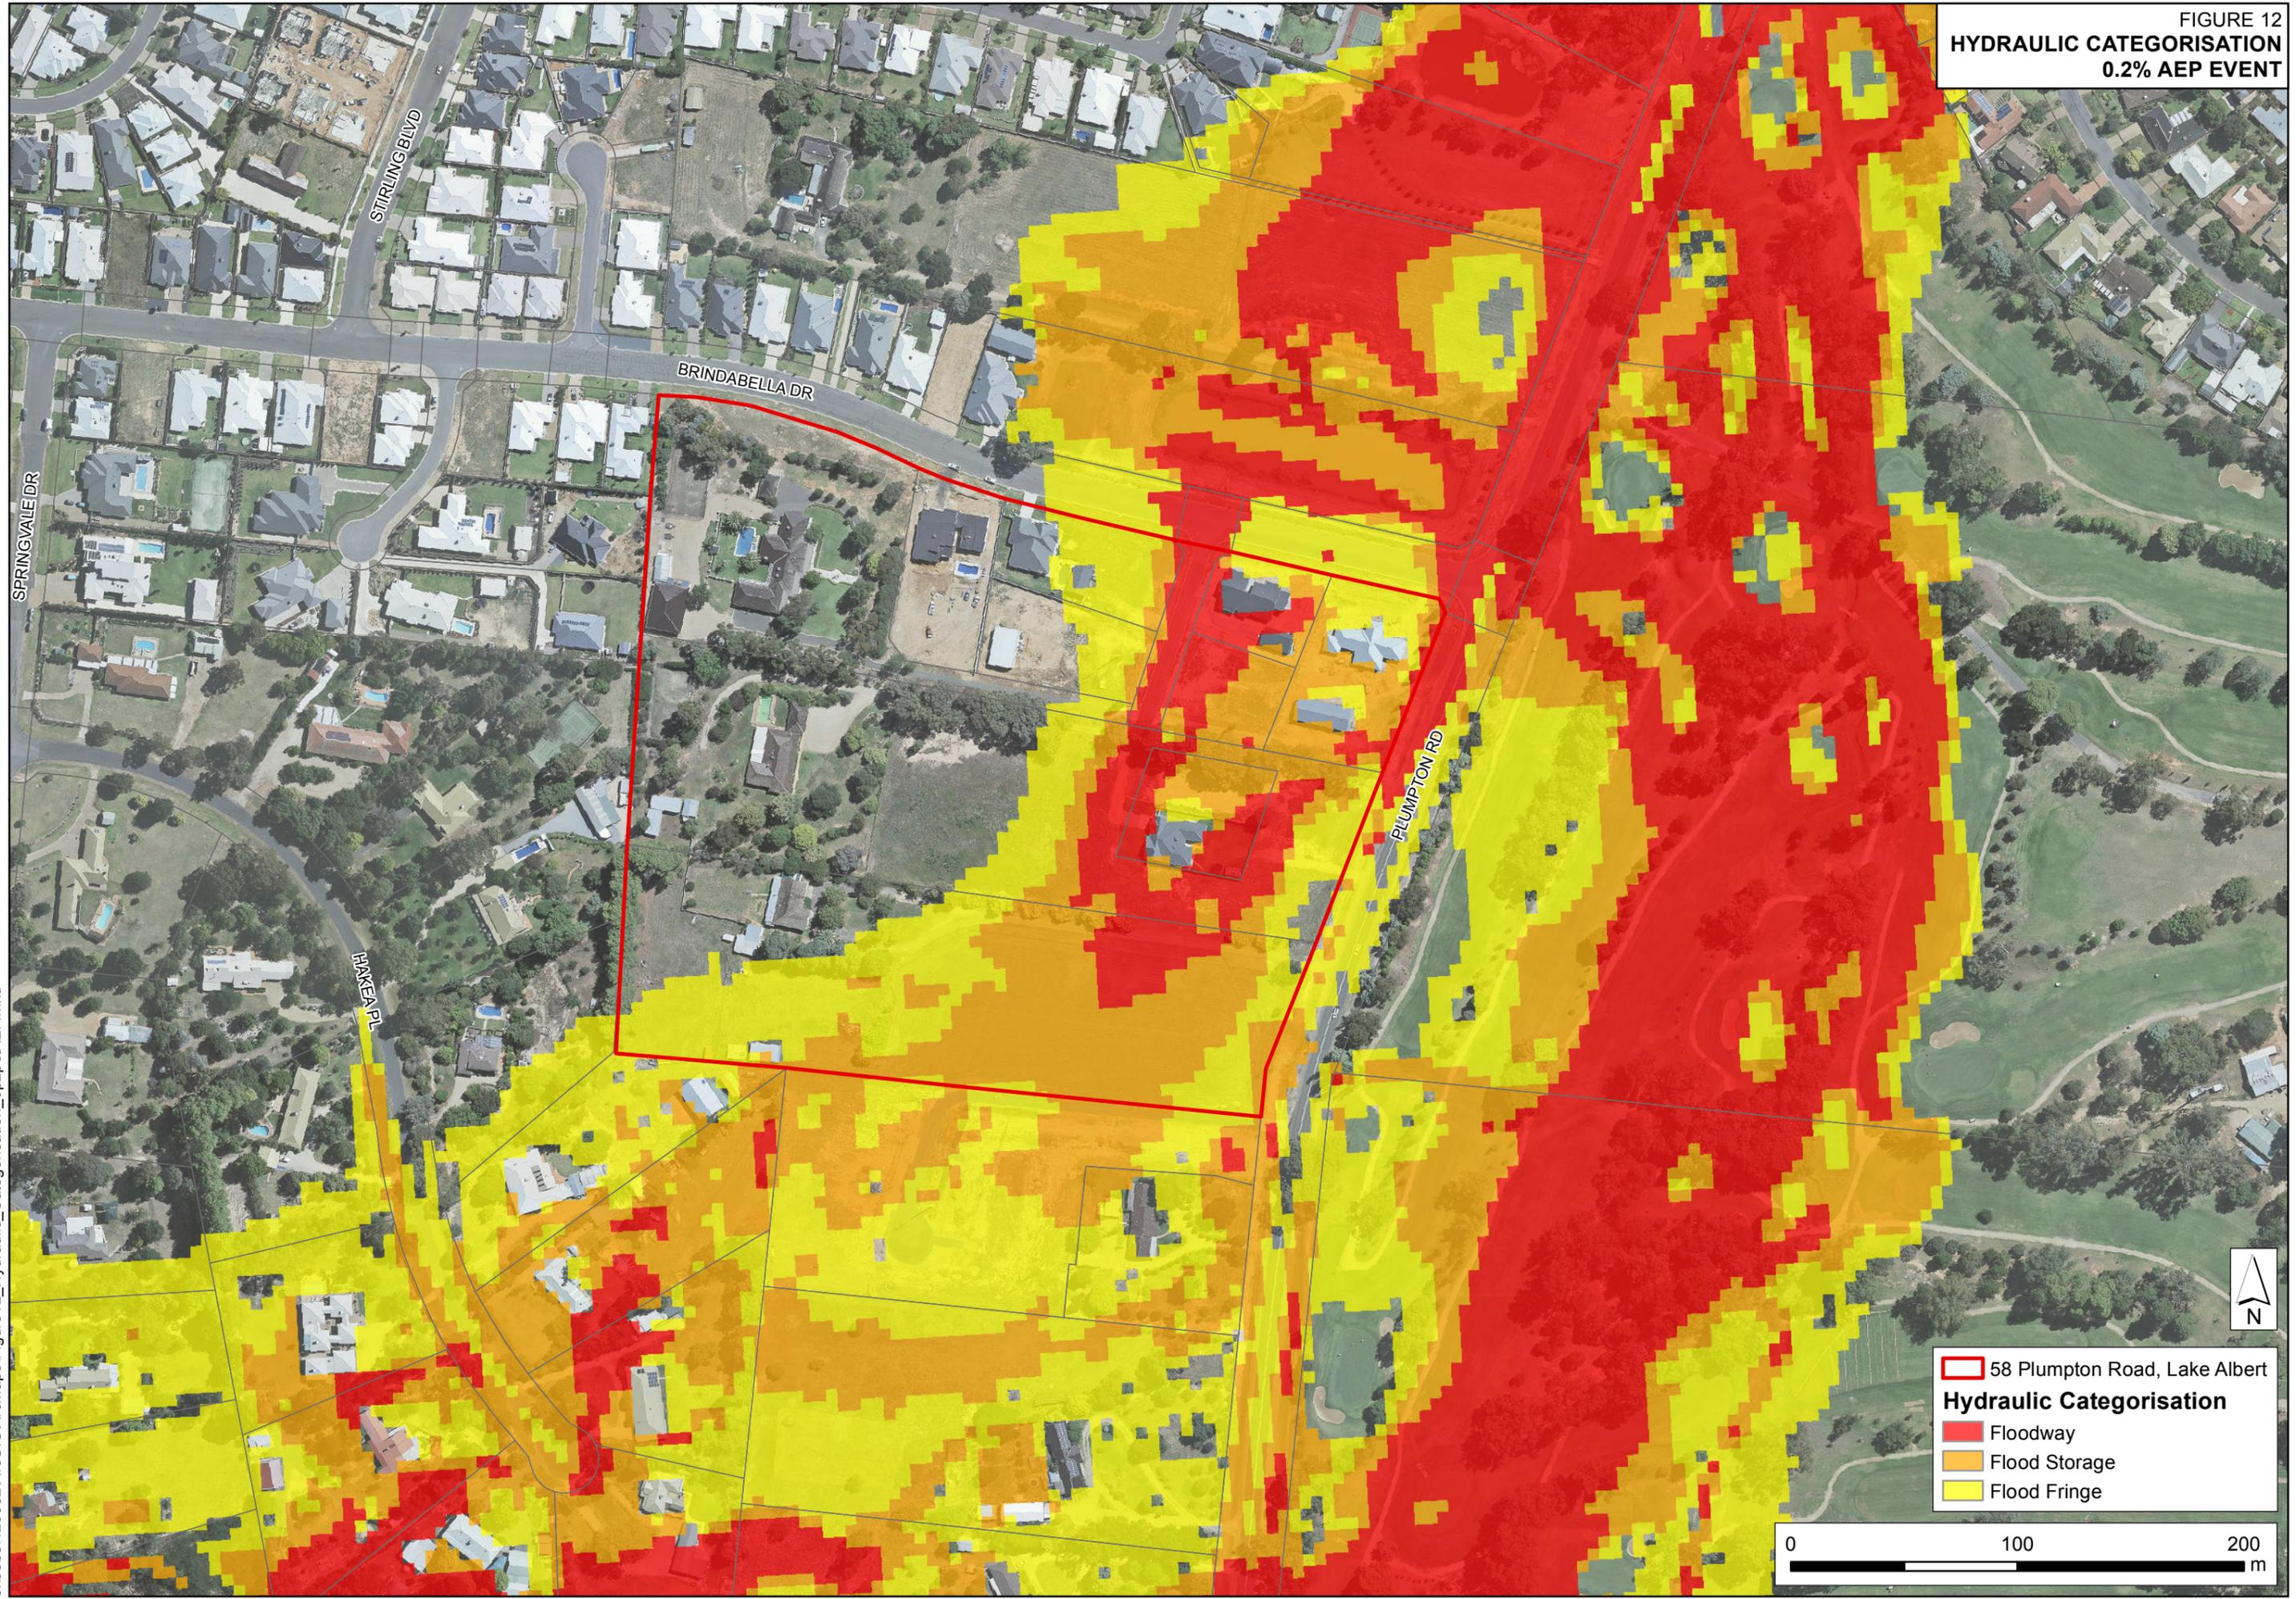
FIGURE 12
HYDRAULIC CATEGORISATION
0.2% AEP EVENT

58 Plumpton Road, Lake Albert
Hydraulic Categorisation
Floodway
Flood Storage
Flood Fringe
